Second Exercise

September 2015

**National Archives of Australia/ACT Fire & Rescue. Part 2
Fire simulations 2012 and 2013 – Ian Batterham.**

Second exercise: 24 May 2013

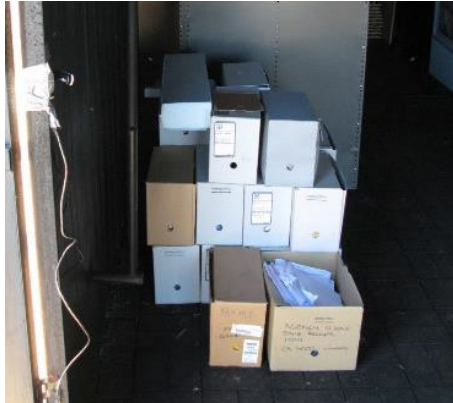
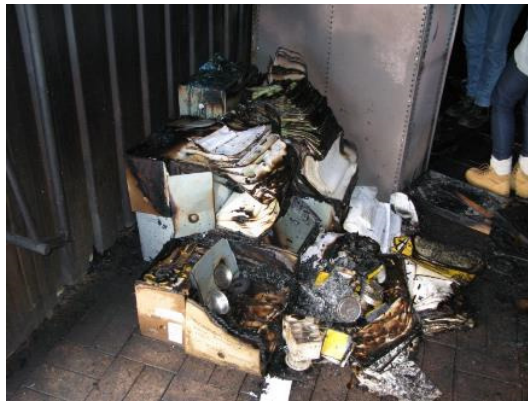
The 'pyramid' of boxes before and after

The 'pyramid' of boxes had sustained quite a lot of damage, particularly considering it was low down, away from the fire source and behind the 'compactus'. Many of the exposed boxes were largely burnt away leaving their contents exposed. In many cases contents had spilt out allowing the fire better access and causing more damage. The polypropylene box on top had completely melted as had the samples of IsoBoard placed on top.

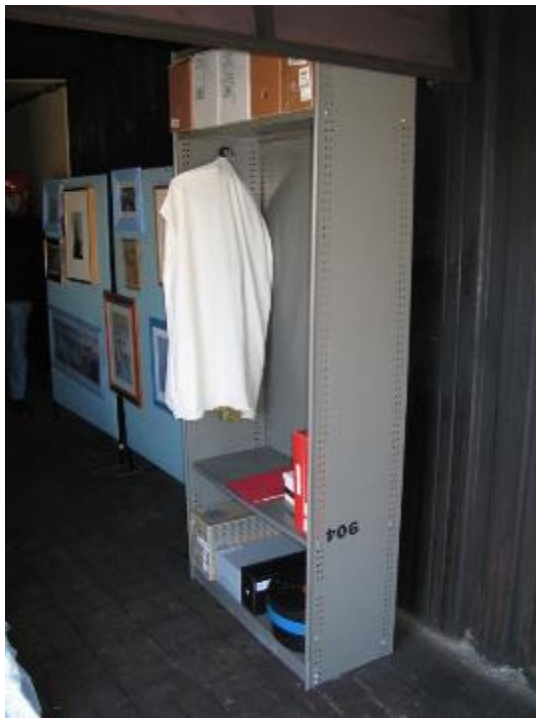
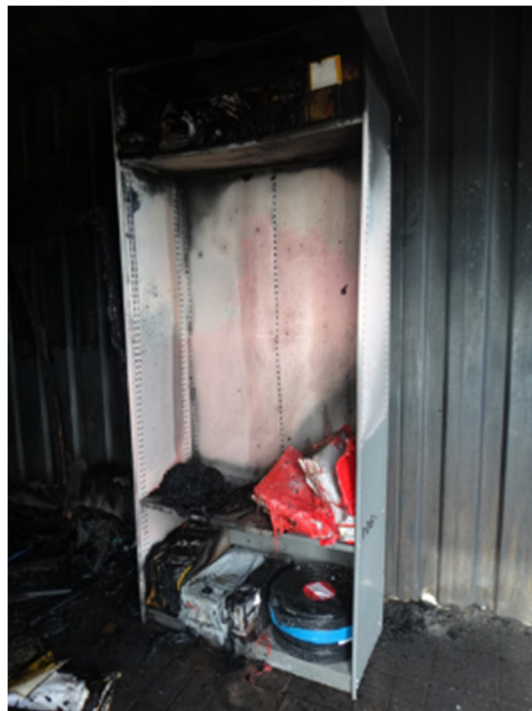
The metal shelving before and after

The metal shelf retained its integrity. The cover of the hanging uniform caught fire and they both dropped to the shelf below. The plastic boxes had melted, exposing their contents to damage as had the gramophone record box. The plastic film cans had melted somewhat but not exposed their contents. The unit was sitting out from the wall and as a result heat reached the back of the items on the shelves, particularly the boxes on the top shelf. Heat transfer through the metal was such that the backs of these boxes caught fire and more damage was done on the side facing inwards than the outside.

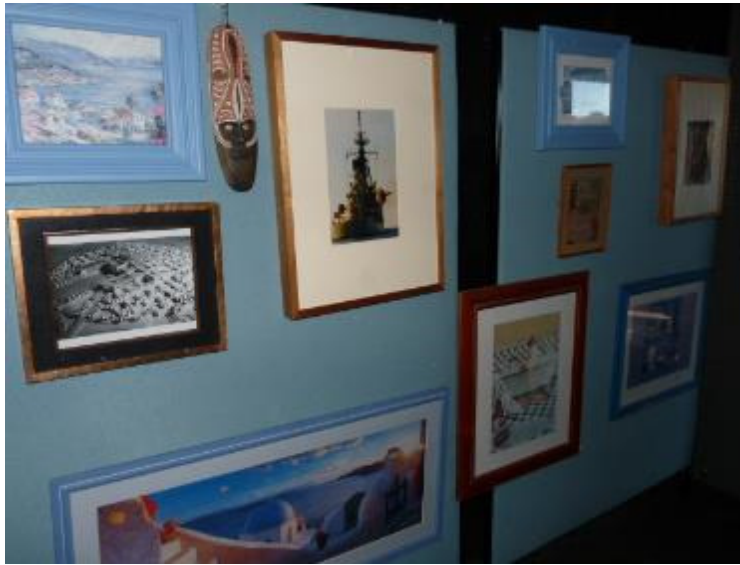
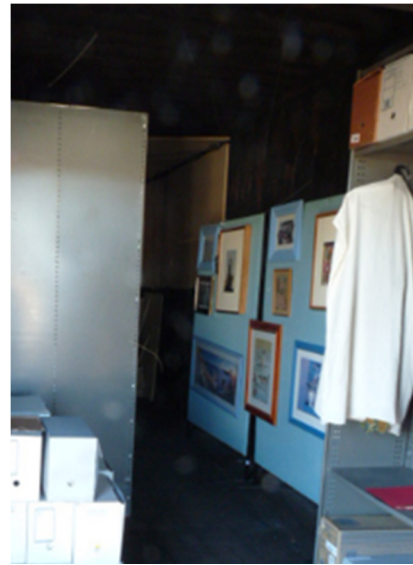
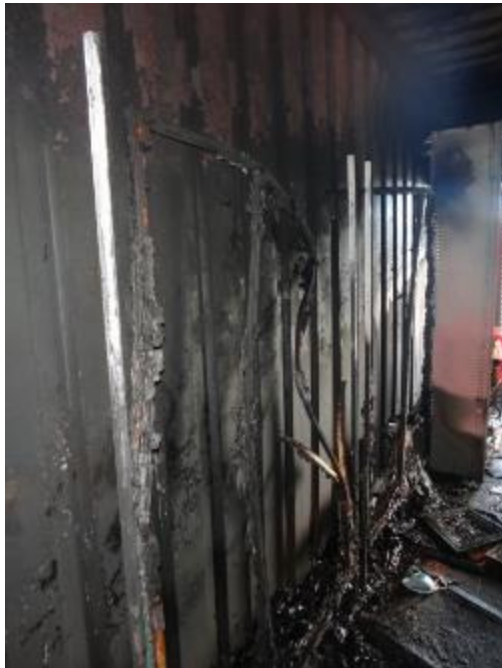
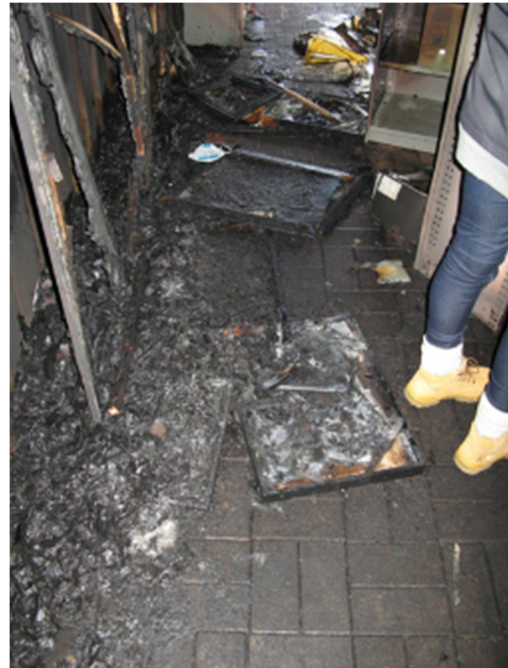
The art screens before and after

The art screens were fairly flimsy affairs and, apart from a metal frame, were all consumed by the fire. Very early in the progress of the fire the pictures started to fall from the screens, it is unsure whether this was a failure of the screws driven into the screens to hang the pictures or of the picture wire/cord. Considerable burning damage was done to the works after hitting the floor.

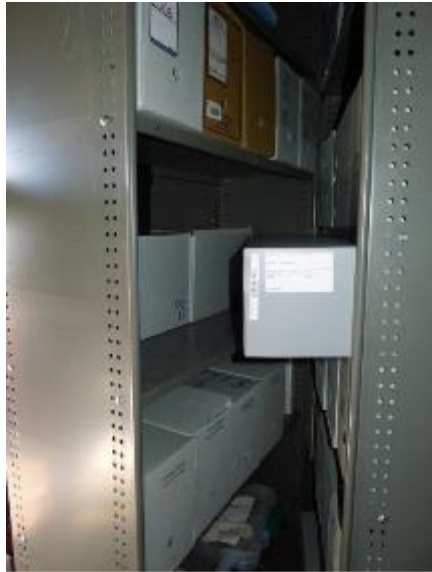
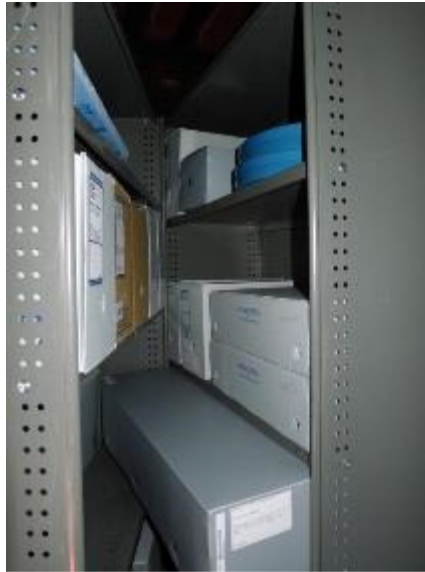
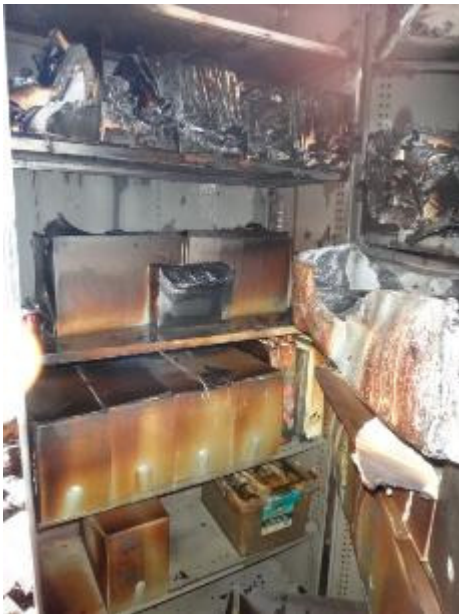
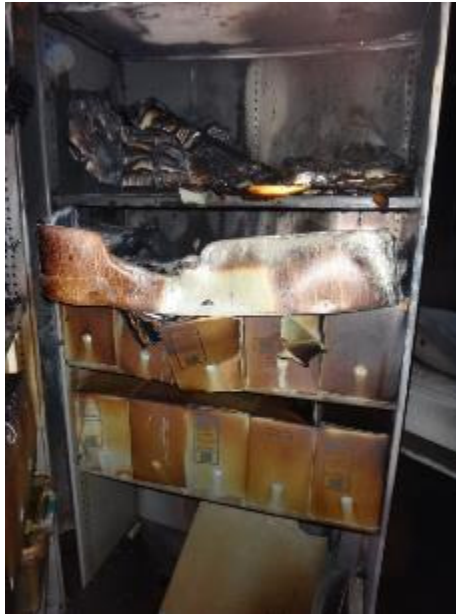
The 'compactus' before and after ('A' left, 'B' right)

It was expected that the compactus would protect its contents from the full force of the fire. The truth was quite the opposite: the contents readily caught fire and considerable damage was done. As with the bay of metal shelving, the fire inside was a result of heat transfer through the metal of the shelving. Furthermore, the fact that the contents were enclosed made it very difficult to extinguish the fire, as water did not easily penetrate. The contents of the compactus continued to smoulder and reignite well after the rest of the fire was out. To fully extinguish the fire inside required the use of large amounts of water which soaked the contents and caused brown decomposition products to be washed down to lower levels. To fully ensure that the fire was out, the firemen eventually pulled the two shelving units apart so they could ensure water got to the smouldering areas.

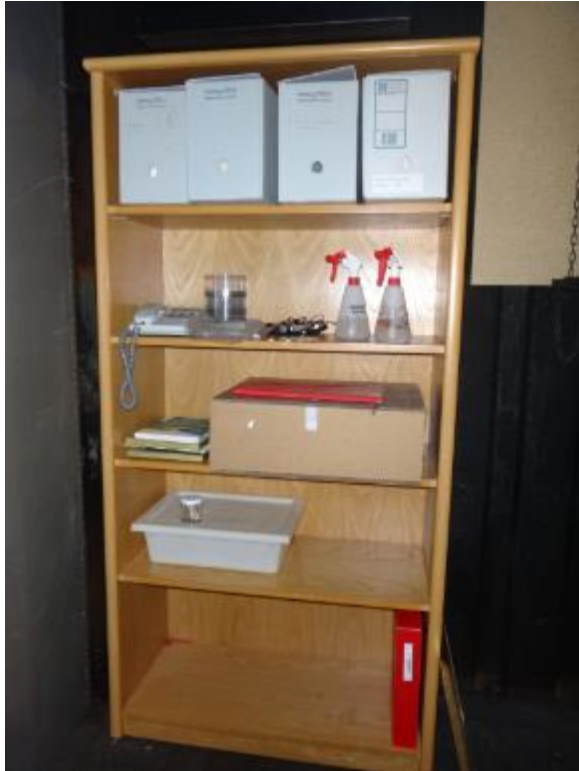
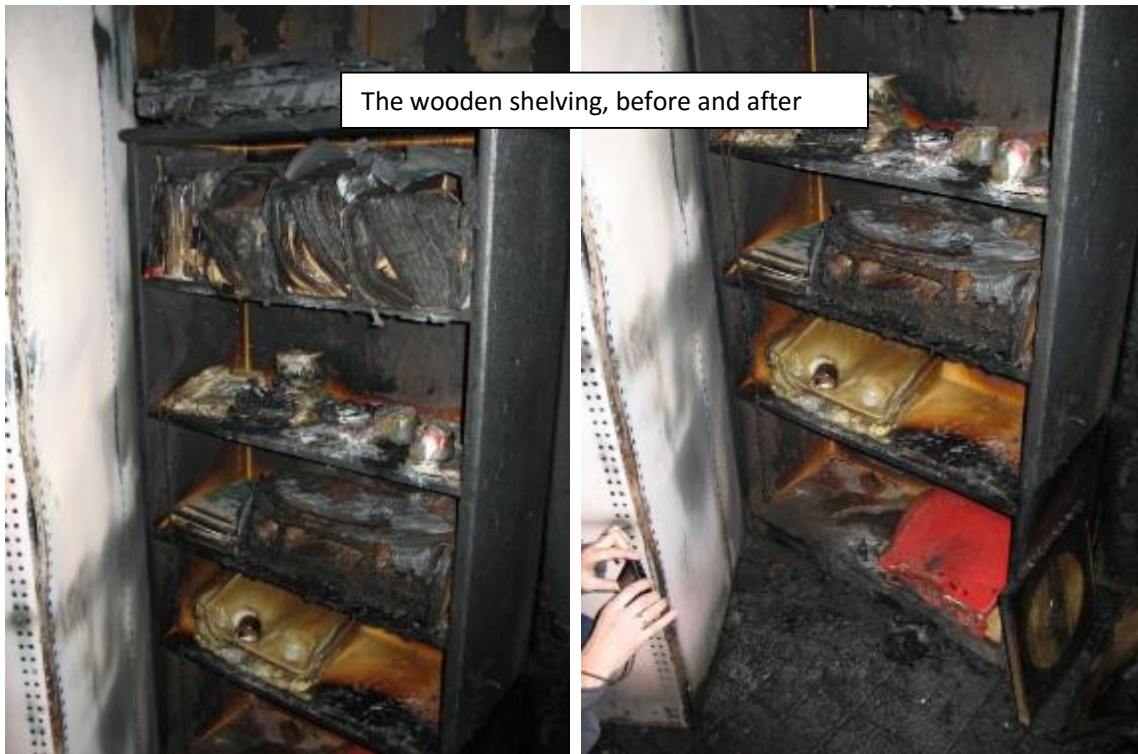
The wooden shelving was close to the fire and facing it directly; its contents therefore sustained a lot of damage. The shelving unit itself retained its integrity and none of the adjustable shelves fell.

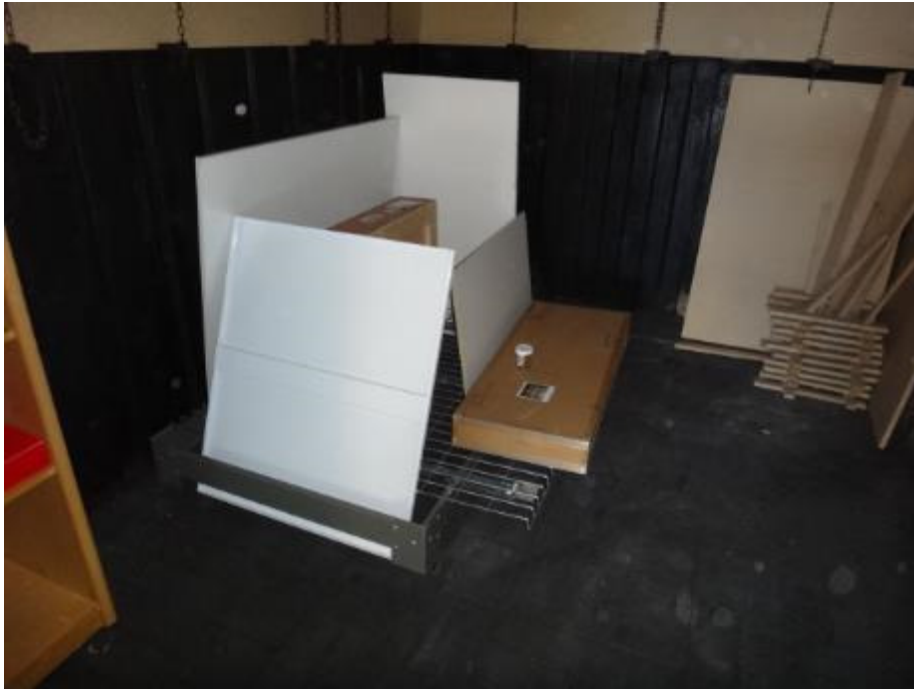
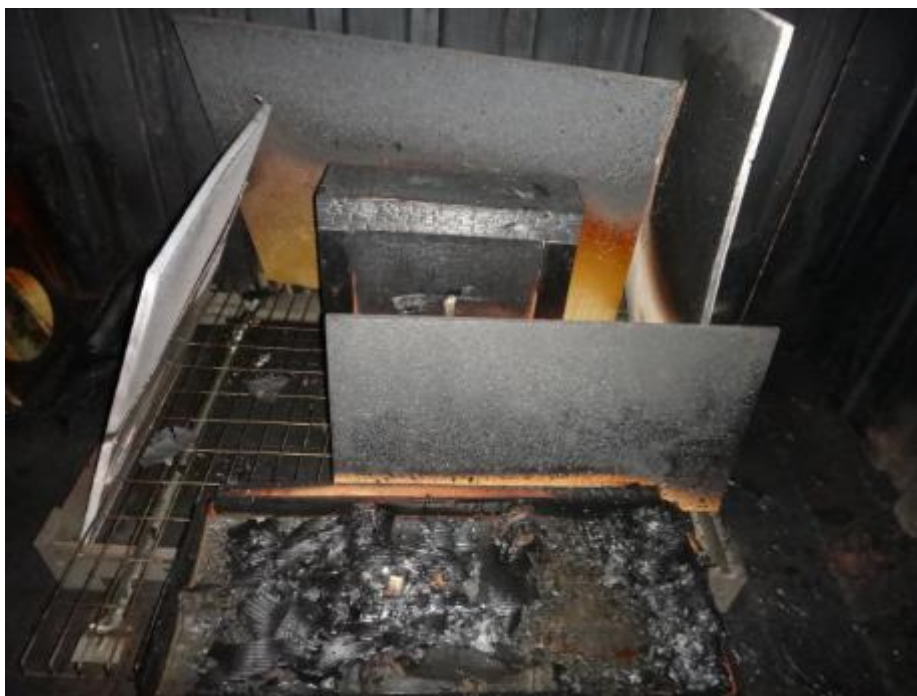
Pile of construction materials, transport crate and storage box, before and after

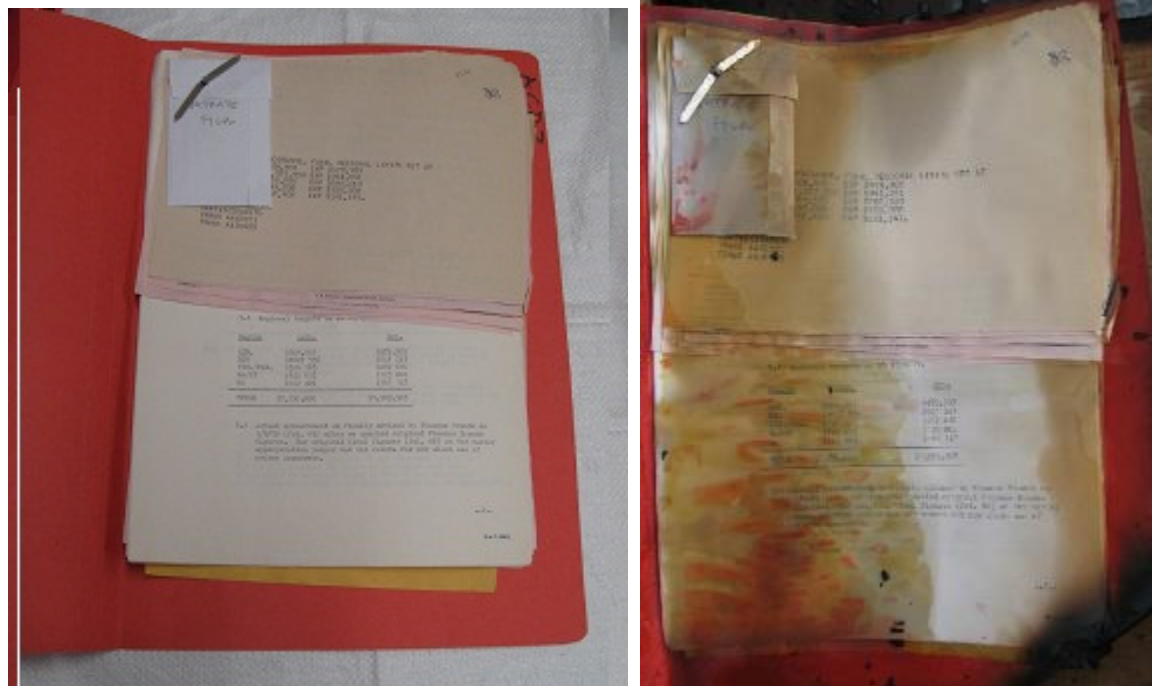
Nitrate film on a file – its presence did not seem to increase the dangers of burning. In this case the film did not burn although the file is singed, in cases where the file was more badly burnt, the nitrate burnt as well. Notice the brown water staining and running of the dye from the red file cover.

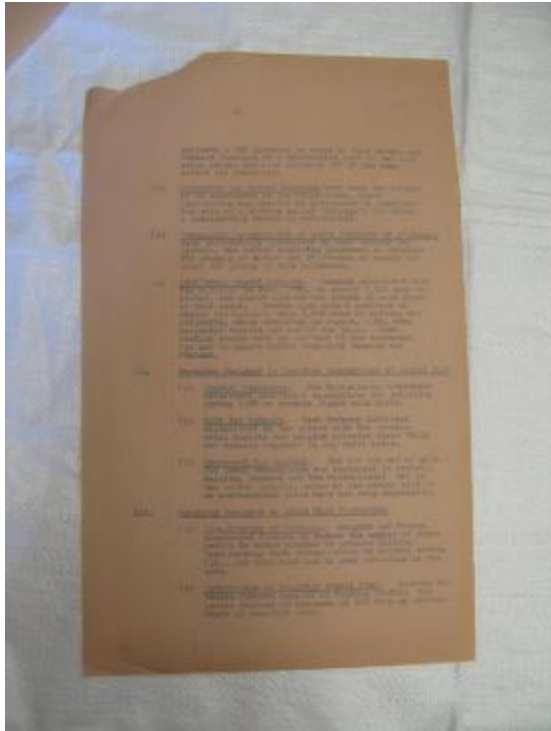
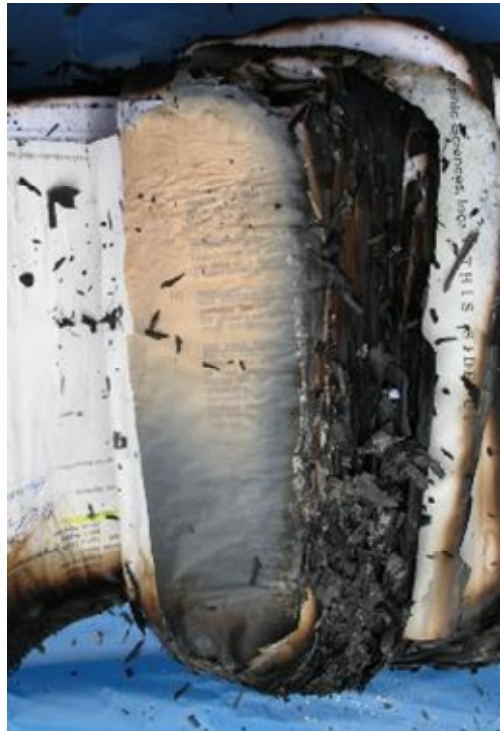
Thermo-fax paper on a file. The paper darkened where it reached a sufficient temperature.

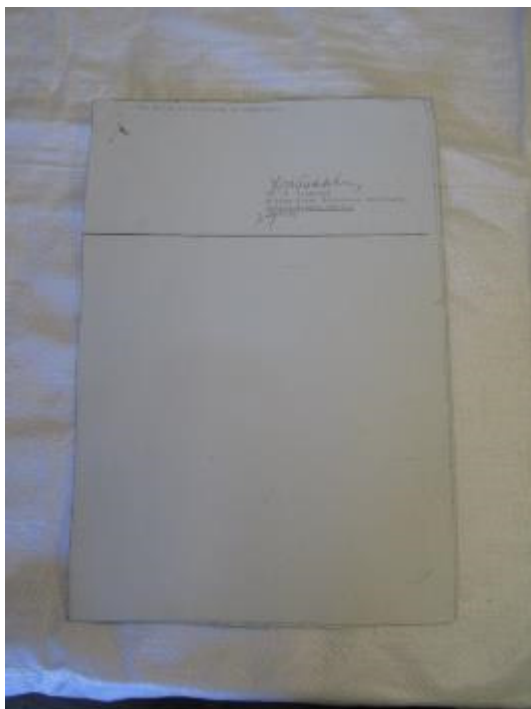
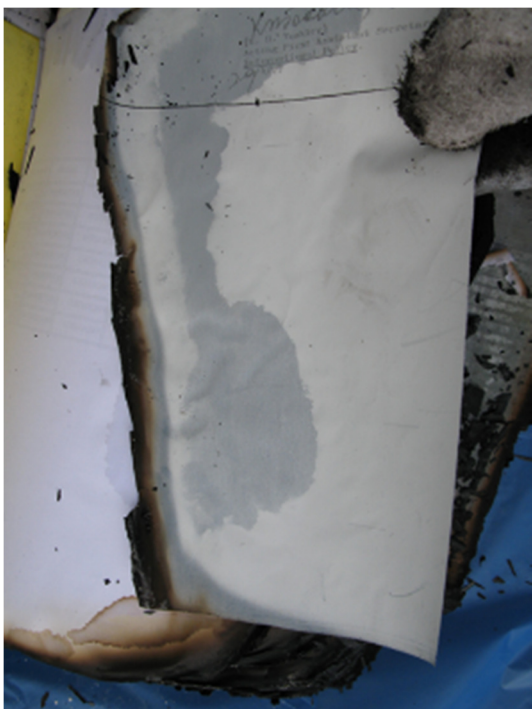
Thermal fax paper on a file. Burnt but did not darken

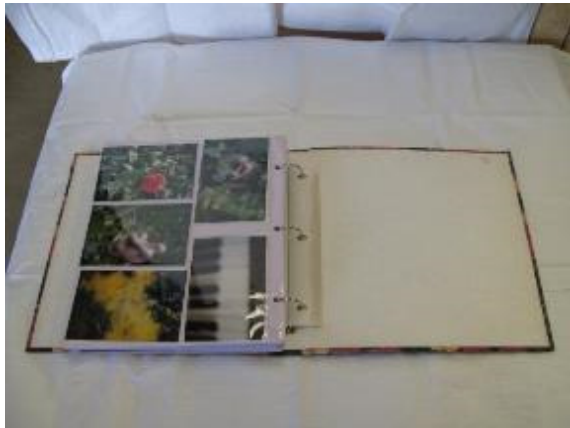
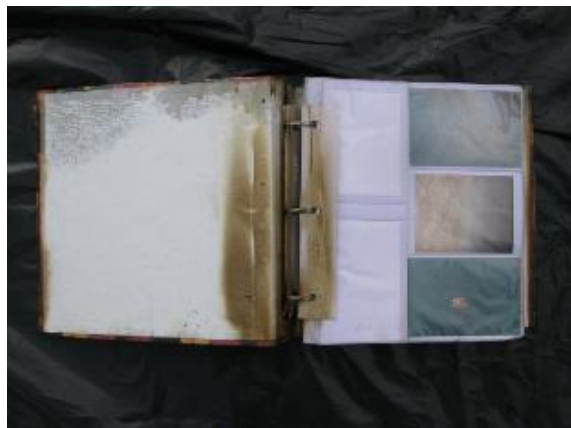
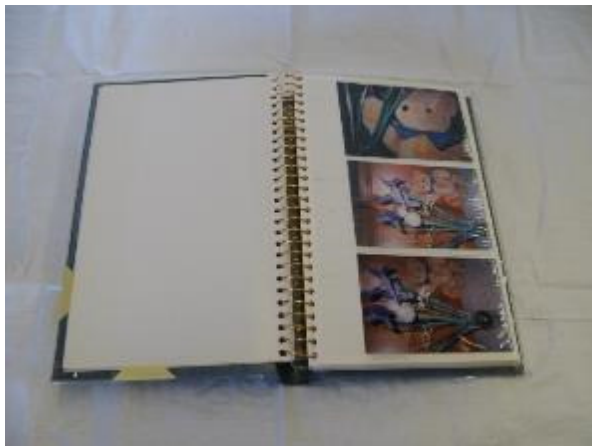
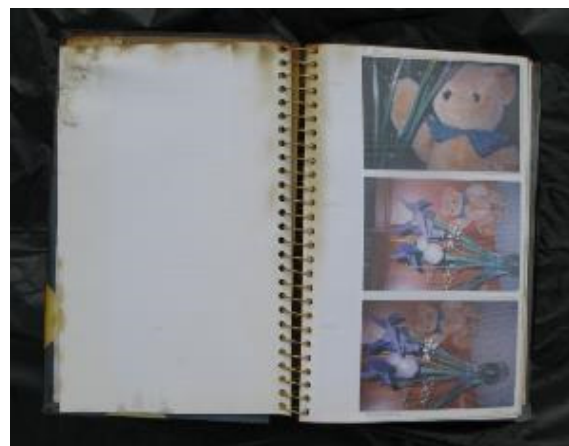
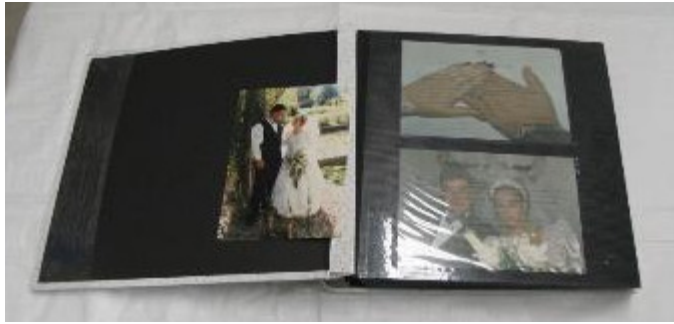
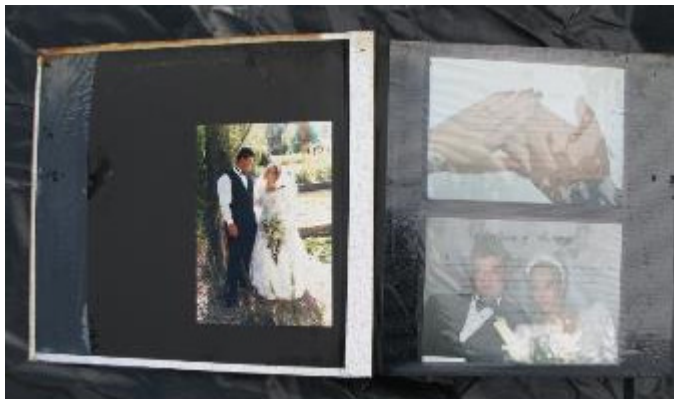
2. Photograph Albums

The photograph albums were packed tightly in the 'compactus'. There was some damage to the albums but the photos survived.

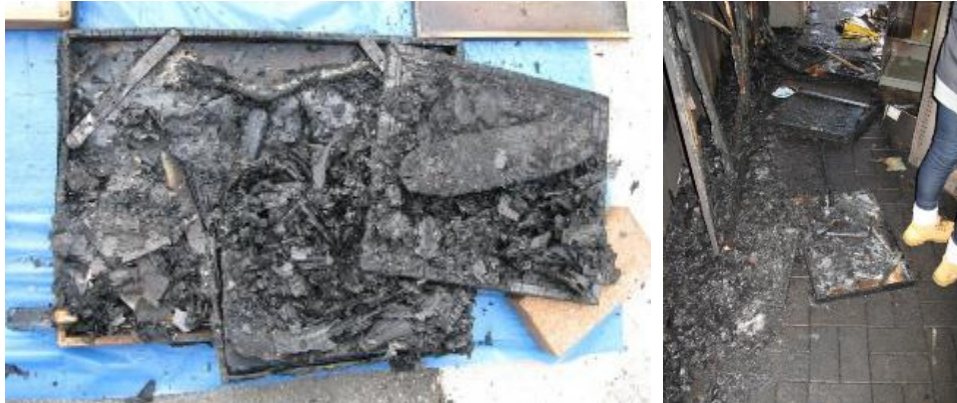
All the framed items fell from the screens, after which the screens were consumed. Damage to the material was related to whether it fell face-up or face-down

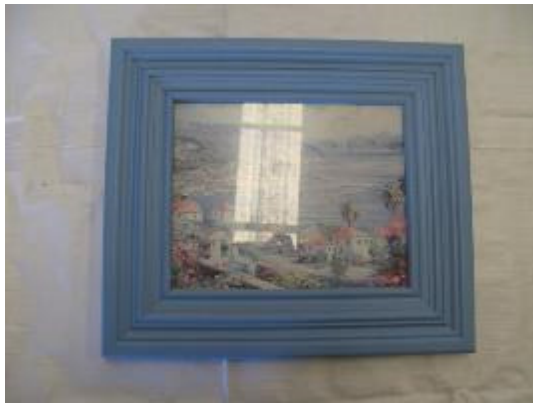
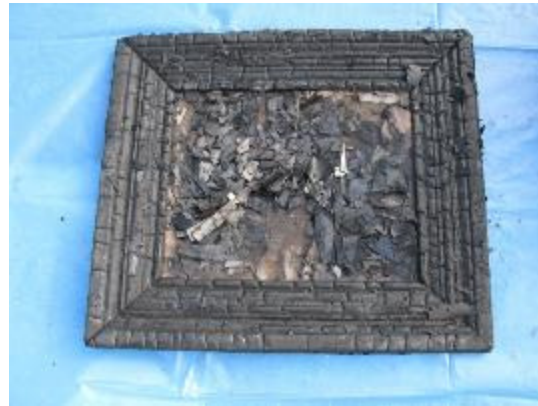
Wooden frame with glass. This item fell face-up and was lost

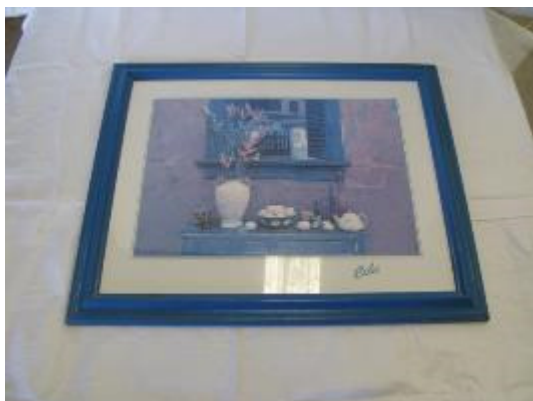
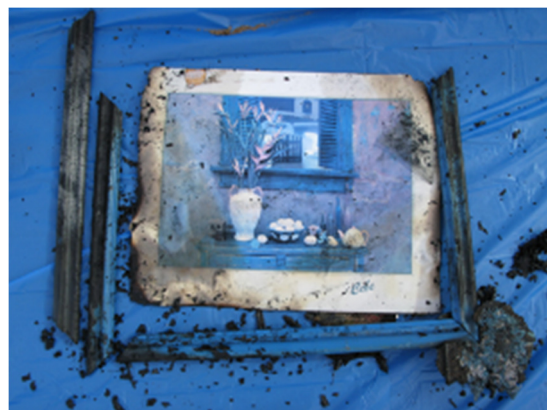
Wooden frame with glass. This item fell face-up and whilst there was much damage, the object survived.

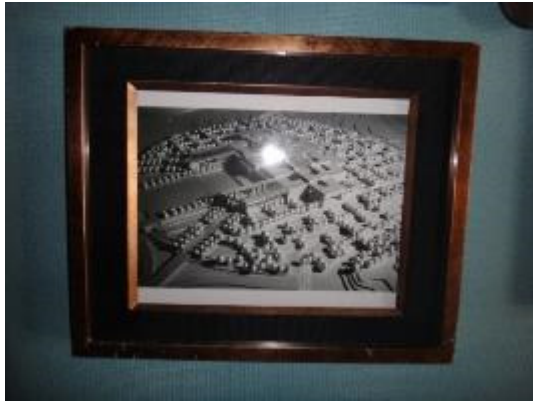
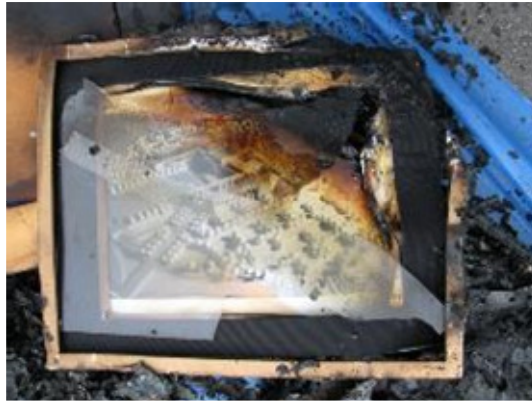
1 artwork in a metal frame glazed with glass	The metal frame fell face down. The corner of the frame closest the fire was actually burnt away, the burning continued into the artwork causing significant loss.
Wooden tribal mask	Charred.

Metal frame with glass. Fell face –down. The metal frame appears to have facilitated heat transfer leading to significant burning of the object.

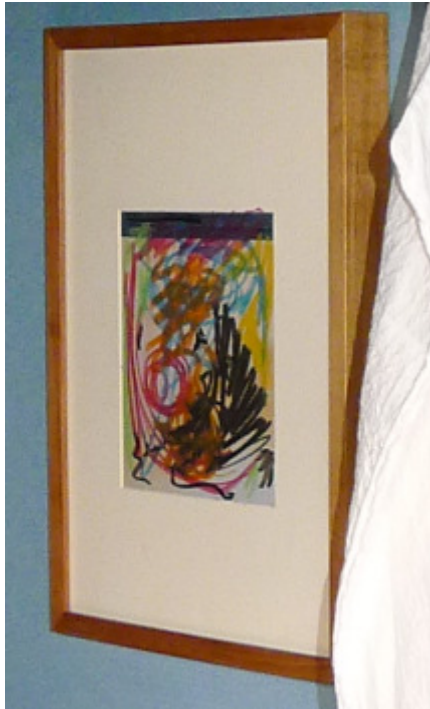
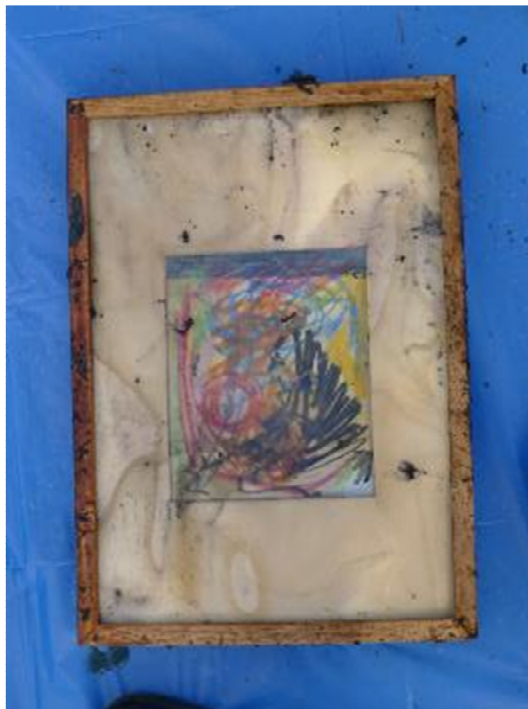
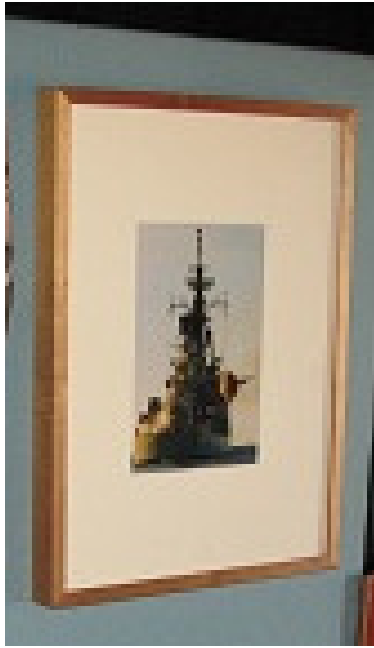
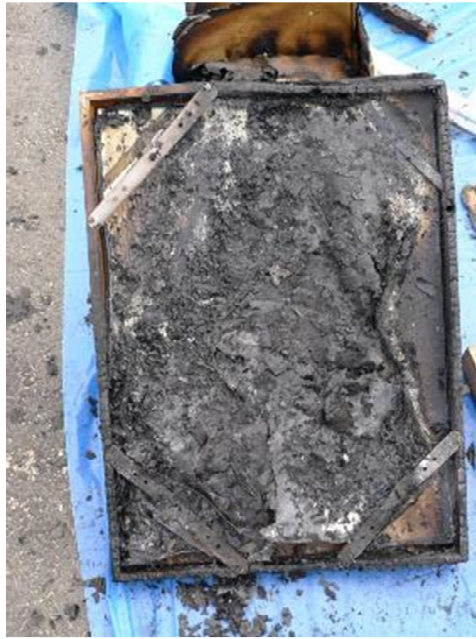
Fini frames – wood with Perspex. Both fell face-down and sustained bad damage to their backs. The objects themselves both survived with some water staining. The pastel (top) dislaved some cracking.

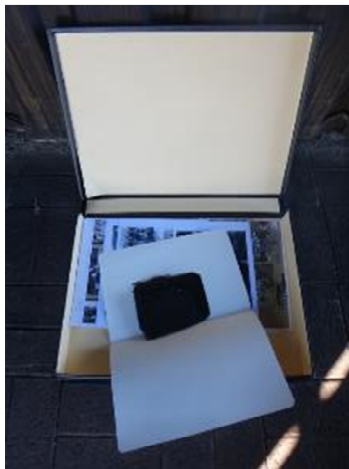
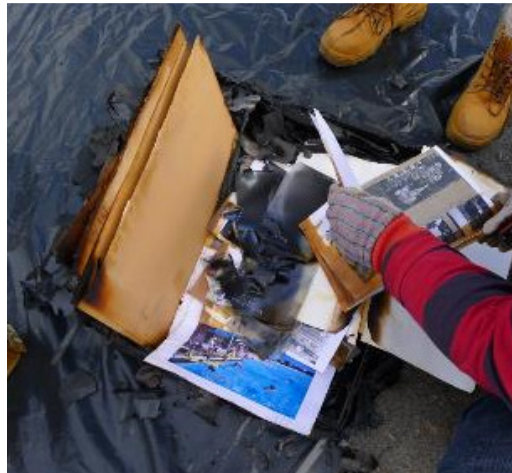
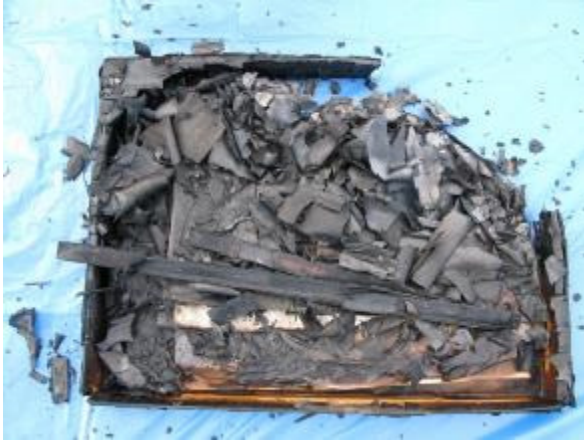
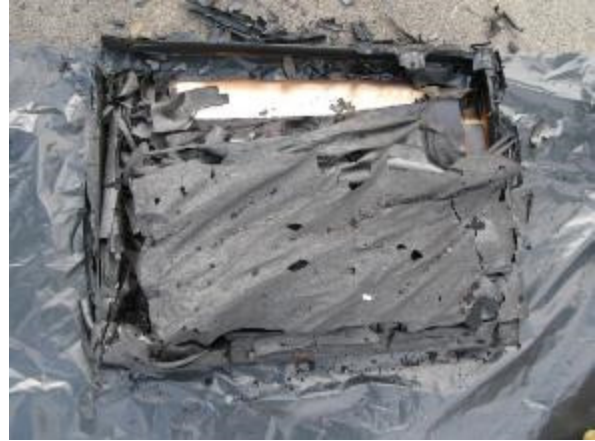
One solander box was placed on top of the wooden shelving and one on top of the metal shelving. The box on the metal shelving (left) sustained the most damage, possibly due to the greater air circulation around it.

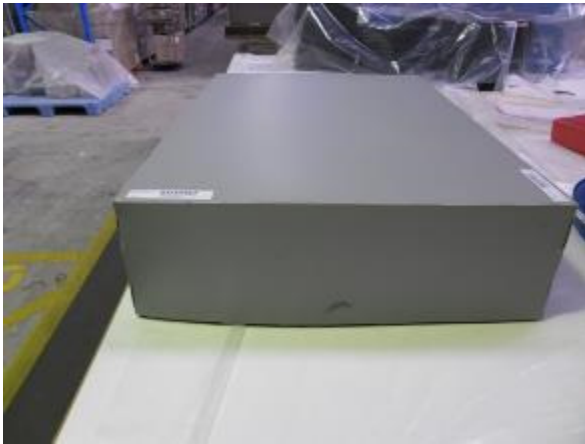
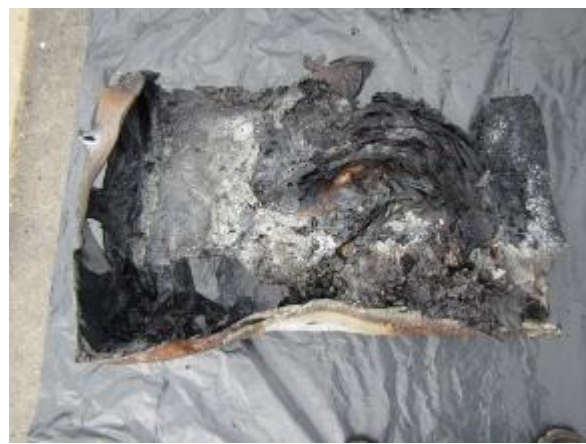
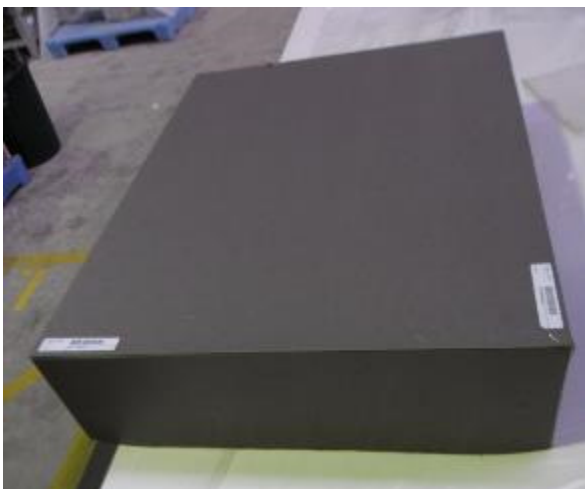
The lab coat in the polypropylene box was on the compactus, unit B, third shelf. The box melted significantly and the contents very badly damaged.

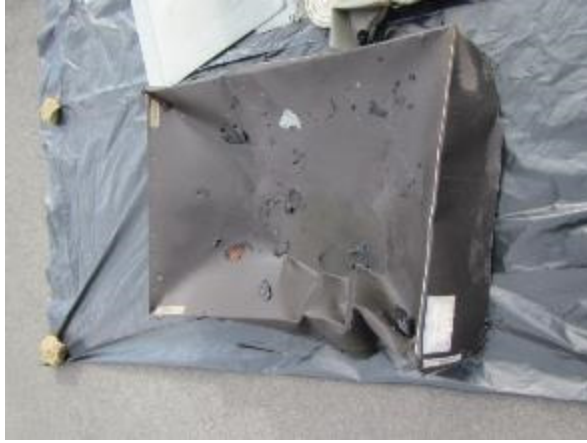
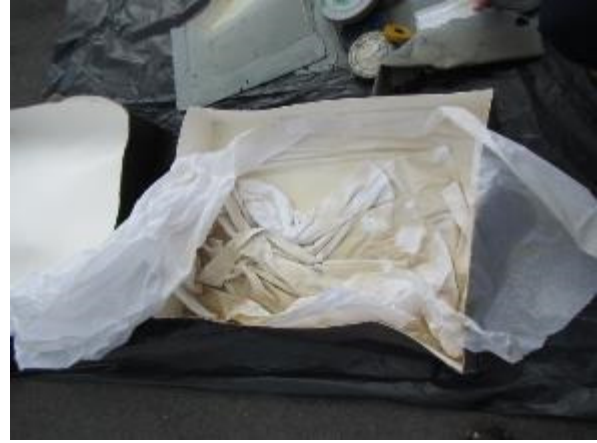
The lab coat in the grey/white board box was on the compactus, unit B, bottom shelf. It sustained no fire damage but was wet and stained.

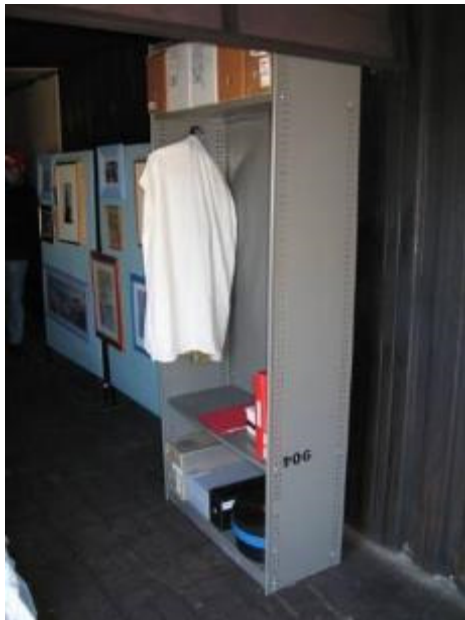
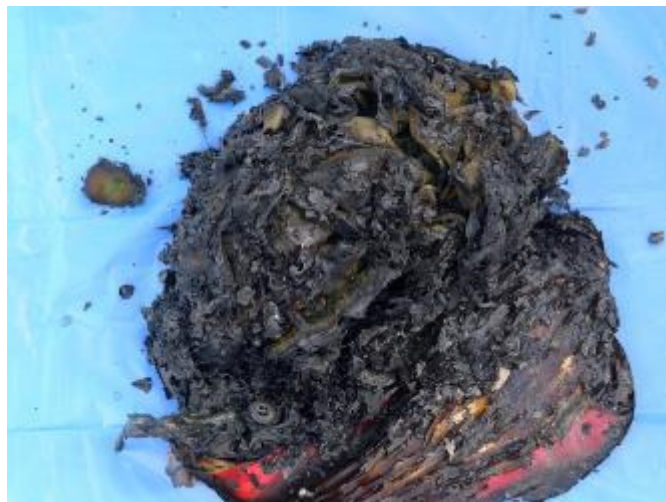
The Disruptive Pattern Camouflage Uniform jacket with cotton dust cover caught fire and fell on to the red file below. The cover was largely consumed and significant damage was done to the uniform itself.

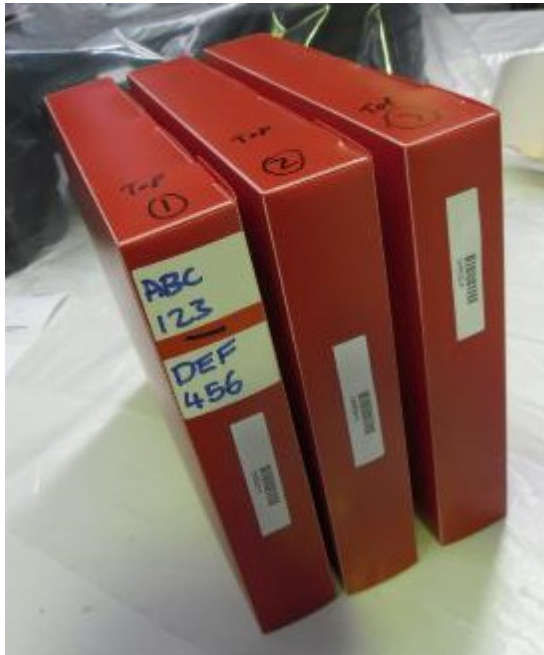
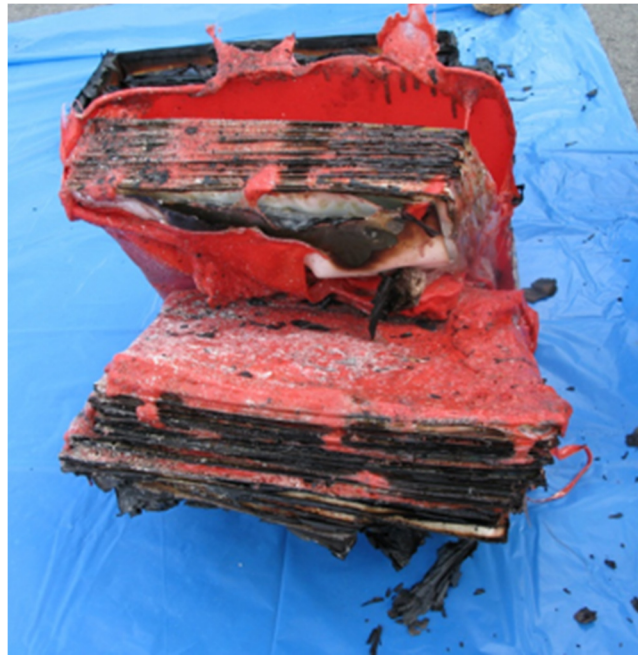
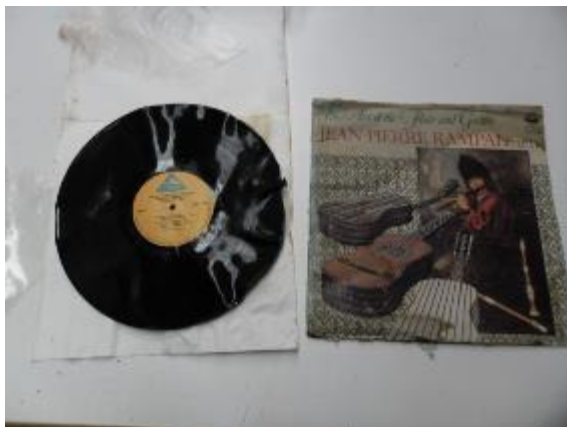
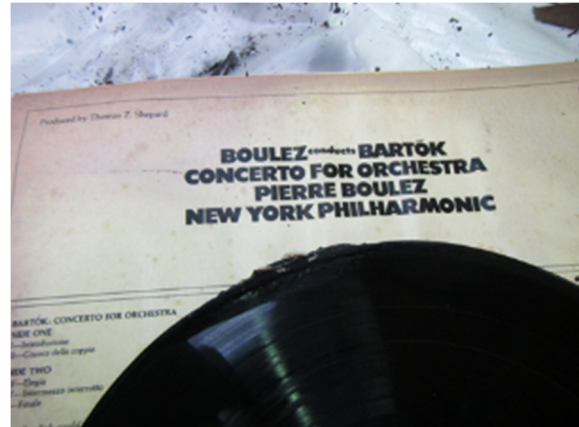
Gramophone records in red polypropylene boxes. The boxes melted and ran. The records were warped, and melted on the edges where they received the greatest heat.

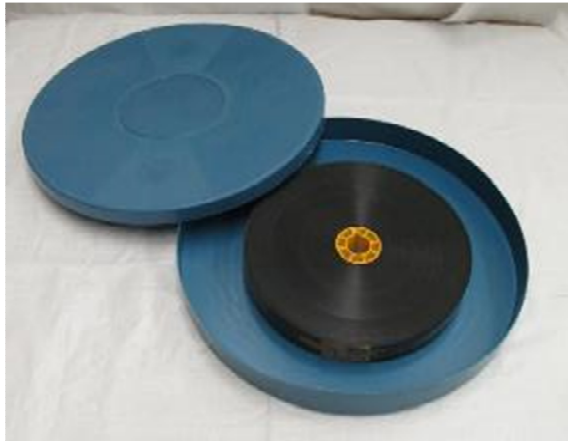
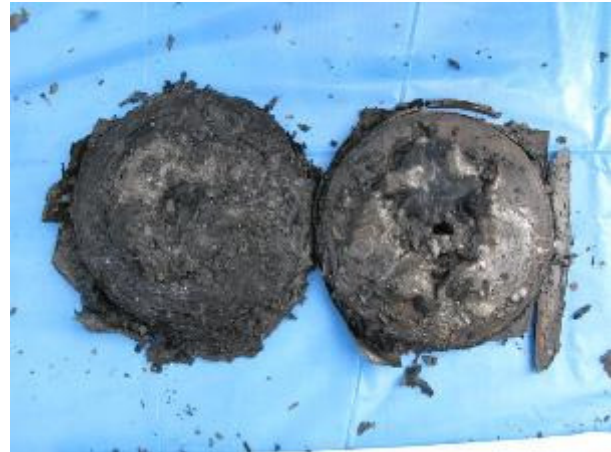
Cine film in plastic film cans. The effects were based on the amount of heat received. The examples shown were at the top shelf of compactus 'B' and were greatly damaged. Other films were less damaged. Often water got into the film can.

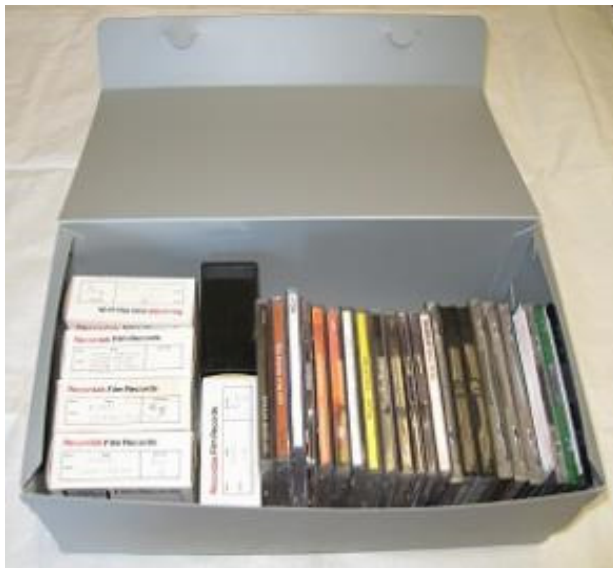
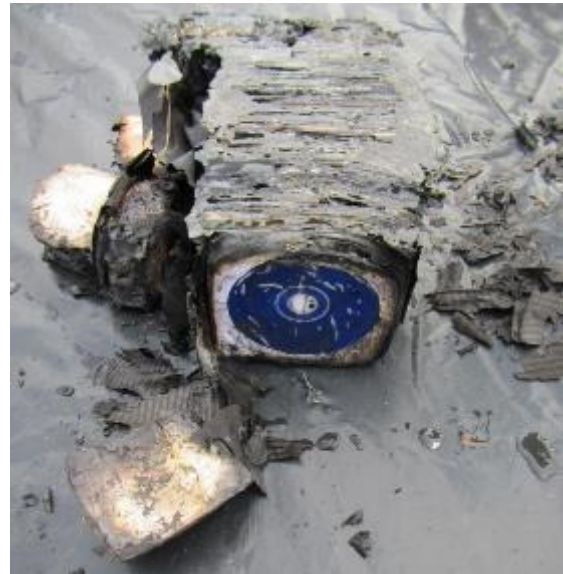
CDs and microfilm. The effects were based on the amount of heat received. The example shown was on the top shelf of compactus 'B' The grey polypropylene box melted, the CDs and films were significantly heat affected.

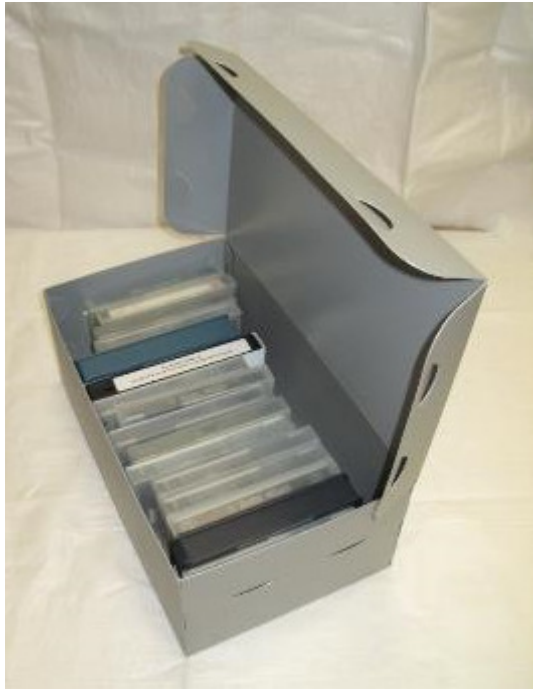
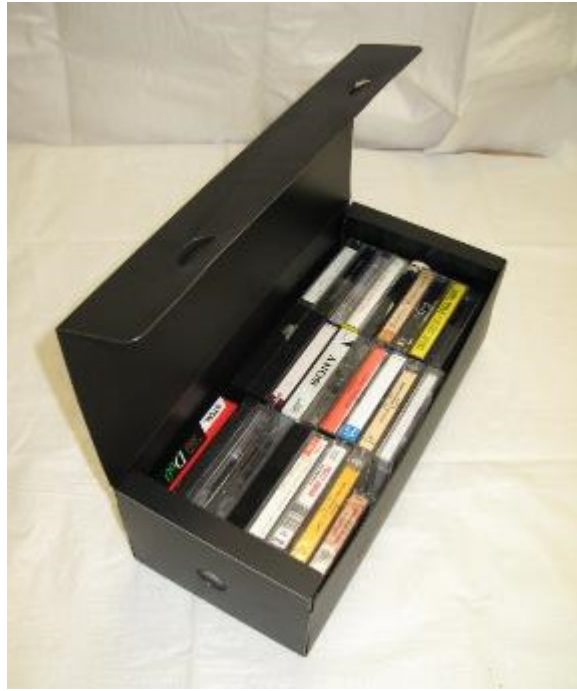
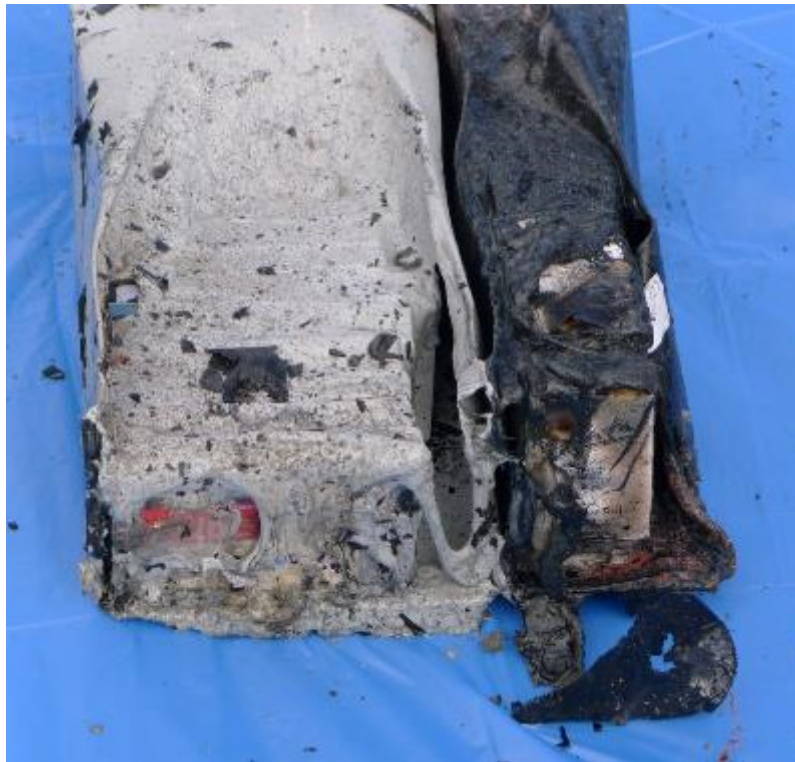
Videos and audio cassettes. These were on the bottom shelf of the metal shelving unit. The boxes had melted, it may have been possible to retrieve some of the tapes.

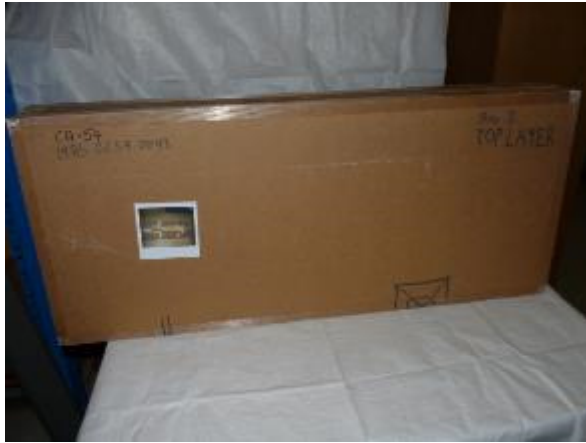
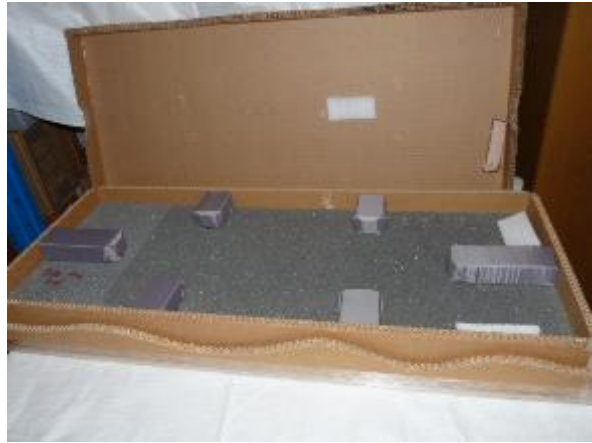
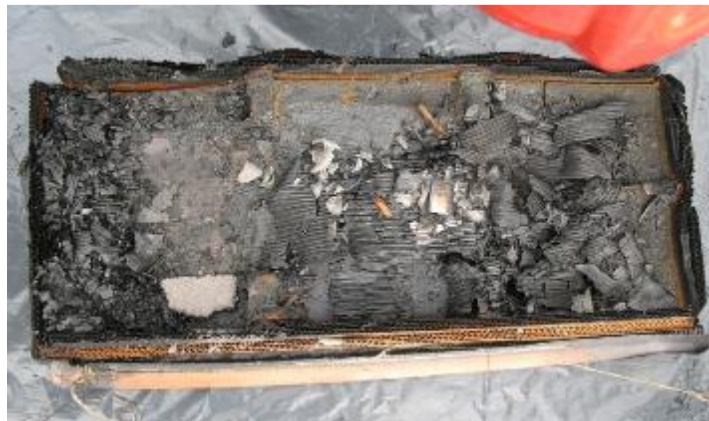
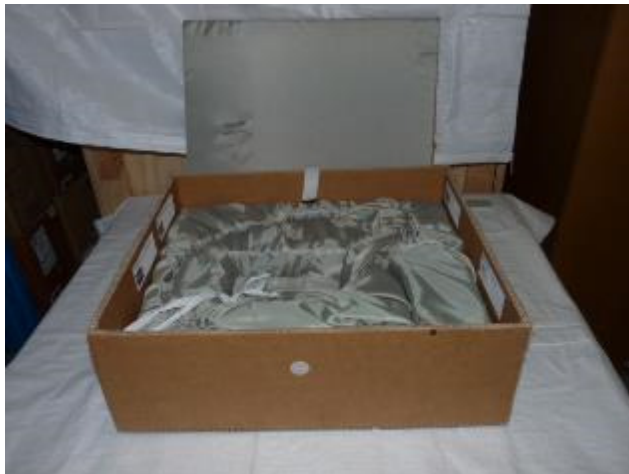
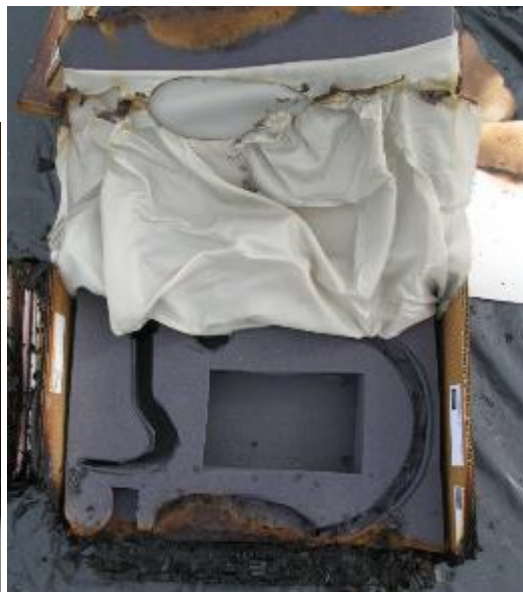
Triwall boxes held together with hot melt adhesive. The box nearest the fire source was largely destroyed. The box on the wooden shelving was only burnt at the front.
