Second Exercise

September 2015

**National Archives of Australia/ACT Fire & Rescue. Part 2
Fire simulations 2012 and 2013 – Ian Batterham.**

Second exercise: 24 May 2013

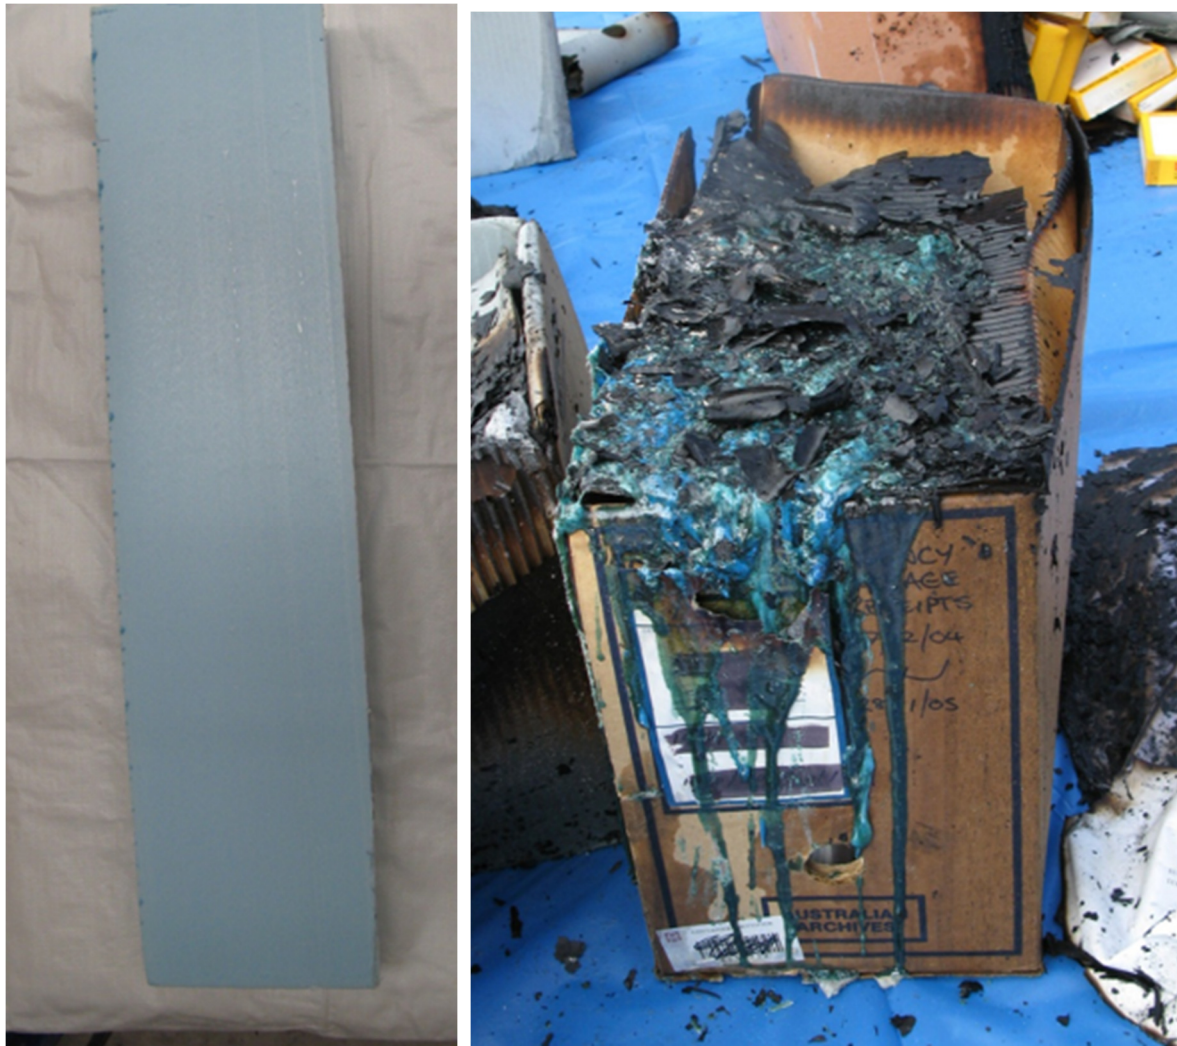
9. Isoboard samples

The Isoboard totally melted but showed no signs of burning
