**Number 51**

**March 2015**

**National Archives of Australia/ACT Fire & Rescue. Part 1  
Fire simulations 2012 and 2013 – Ian Batterham.**

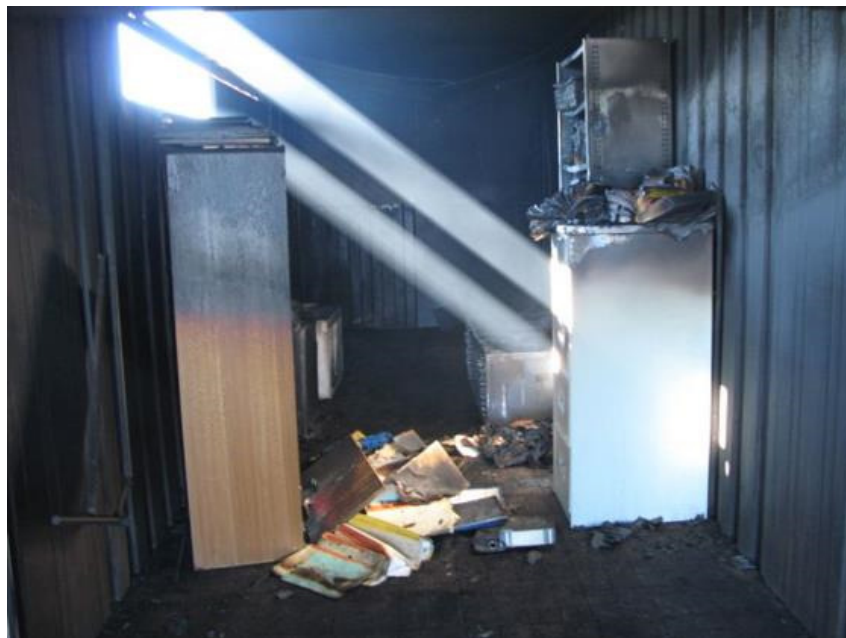
20. THE SCENE WHEN WE WERE ALLOWED TO ENTER PHOTOGRAPHER JENNIFER EVERART

On entering the container after the fire it was clear there was a lot of damage (Figs 20 & 21). A large number of in situ photos were first taken and then items were carefully moved outside. The material and furniture were then packed up and moved to the NAA's Greenway building. The next day the material was carefully examined and each item was rephotographed.

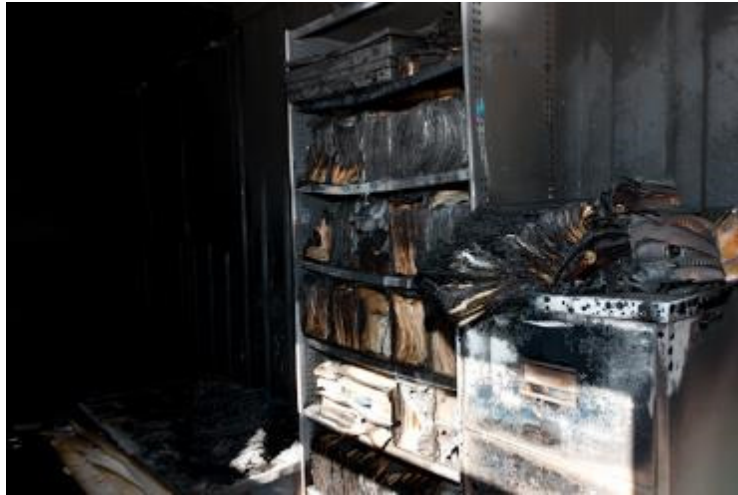
21. VIEW OF THE METAL SHELVING AND FILING CABINET PHOTOGRAPHER JENNIFER EVERART

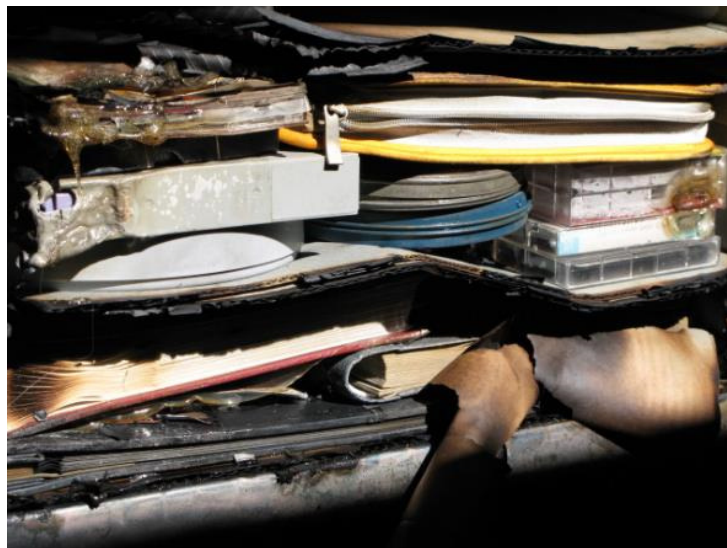
The exercise did not answer this directly. It can be assumed however that damage was more significant for materials where the medium is delicate and the information is packed densely. Thus AV materials would be considered most vulnerable (Fig 22).

22. CDS, FILM, AUDIO TAPE, VIDEO TAPE AND PHOTO ALBUMS AFTER THE FIRE

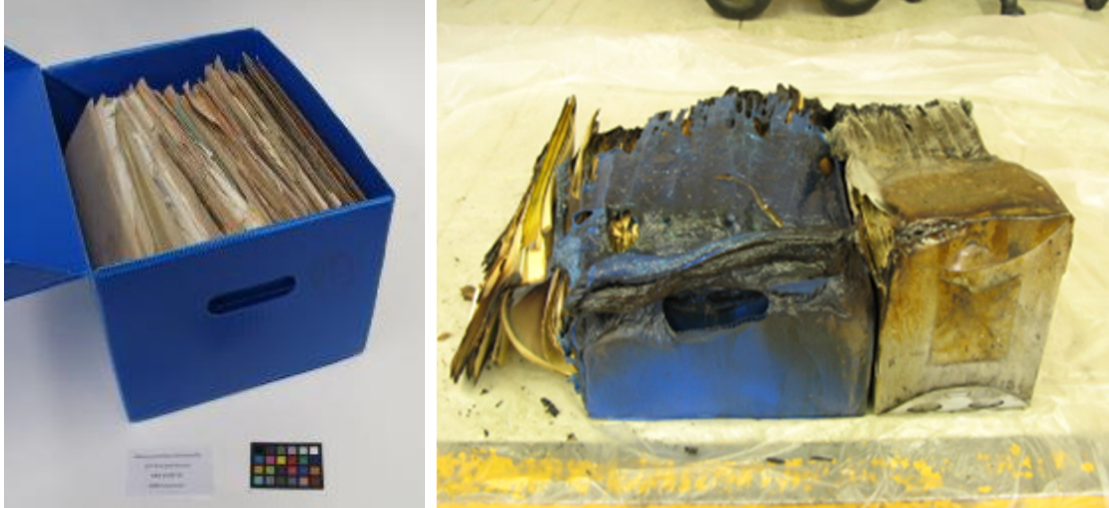
There was a distinct difference between materials stored in corrugated paperboard, when compared to material stored in polypropylene (whether fluted or not). The corrugated paperboard burnt but in doing so appeared to protect the material stored within. The polypropylene boxes on the other hand melted and left the contents exposed to the fire. The lid of the box when melted ran into the box, covering the contents (Figs 23-29).

23 & 24. FLUTED POLYPROPYLENE BOX (STAMINEX) PACKED ON SHELVING - BEFORE AND AFTER (WITH POLYPROPYLENE ALBOX BESIDE)

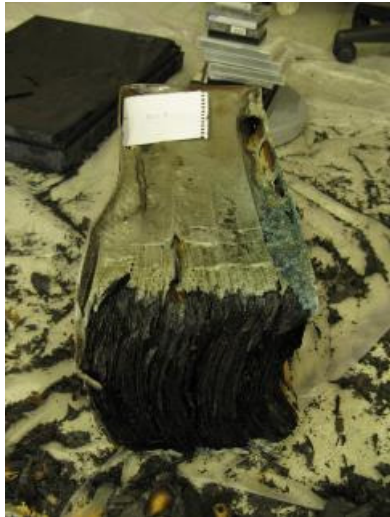
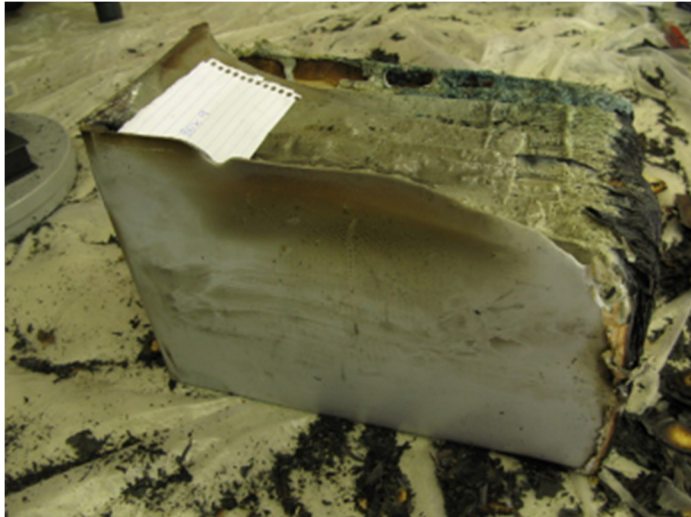
26 & 27. POLYPROPYLENE BOX (ALBOX) PACKED ON SHELVING - AFTER

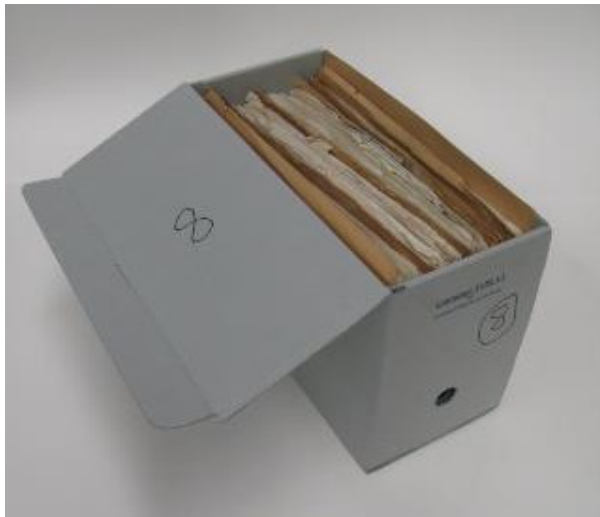
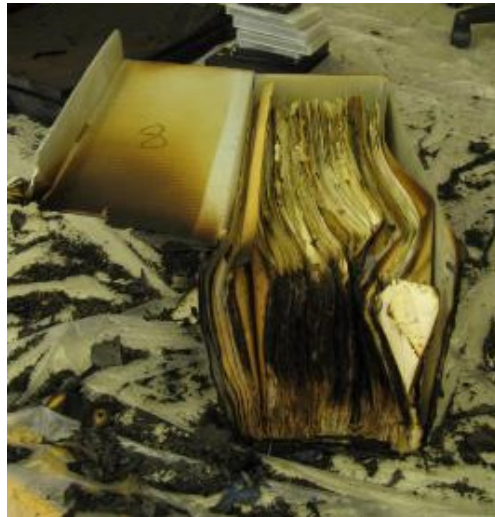
28 & 29. ARCHIVAL CORRUGATED PAPERBOARD BOX PACKED ON SHELVING — BEFORE AND AFTER

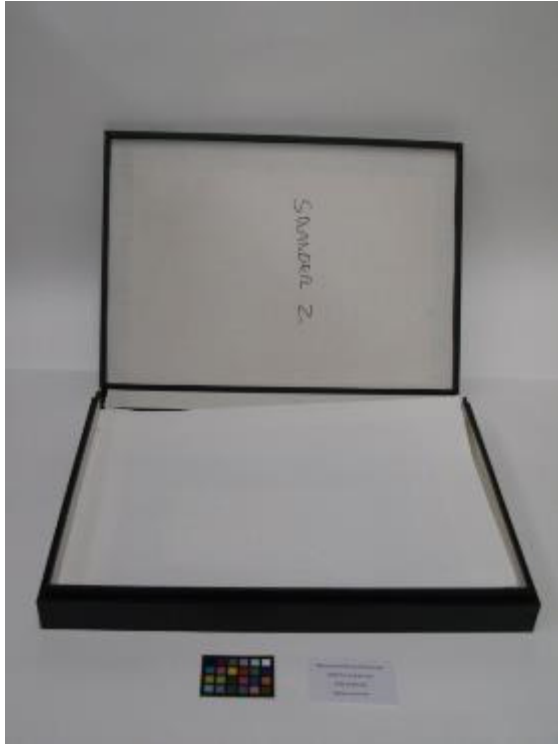
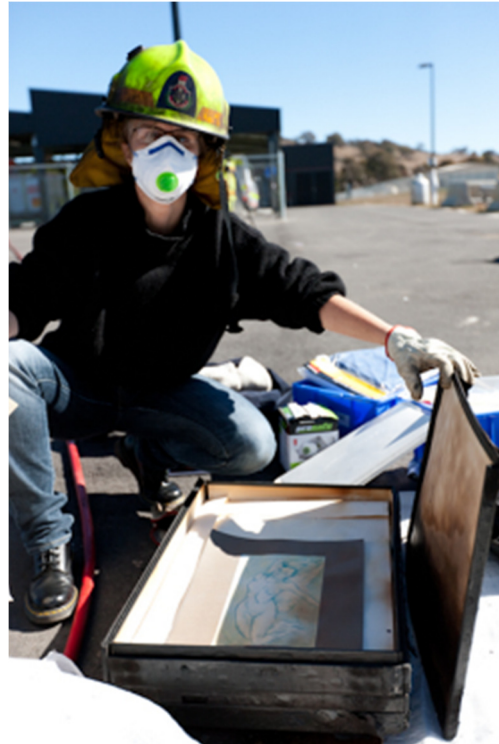
It was very difficult to compare box styles (as opposed to fabrication materials) and no style seemed to behave better than another. The Exception was the Solander box which appeared to offer significant protection (Figs 30 & 31).

30 & 31. THE SOLANDER BOX WAS CHARRED BADLY BUT THE CONTENTS SURVIVED

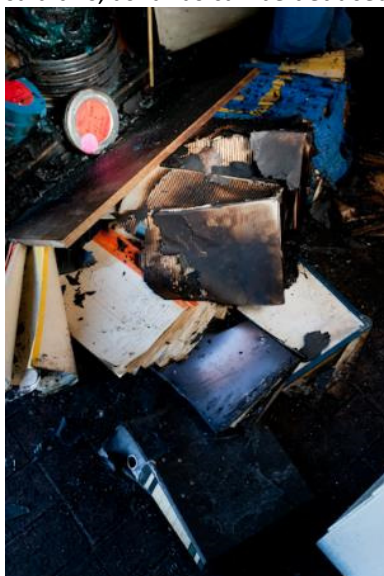
This was hard to assess. Unfortunately the wooden shelving used was the type where each shelf is held up using plastic plugs. These apparently melted leading to the shelves falling on the floor (Fig 32). Having said this, as far as can be deduced there was little difference between the two shelving materials.

32. THE COLLAPSED WOODEN SHELVING

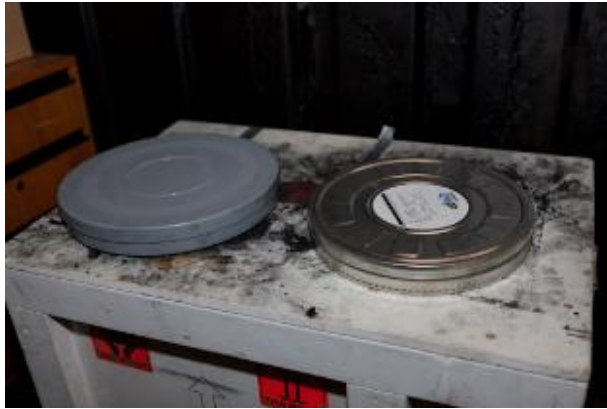
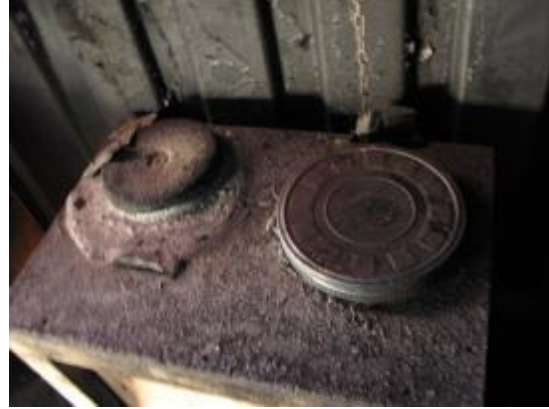
It is very difficult to make a conclusion about this question. Plastic containers tended to melt, metal containers appear to have acted like ovens and the paperboard container charred. In each case there was significant damage to the film inside and it was not possible to say which film received the worse damage (Figs 33-45).

33 & 34. POLYPROPYLENE AND STEEL FILM CANS IN THE OPEN – BEFORE AND AFTER

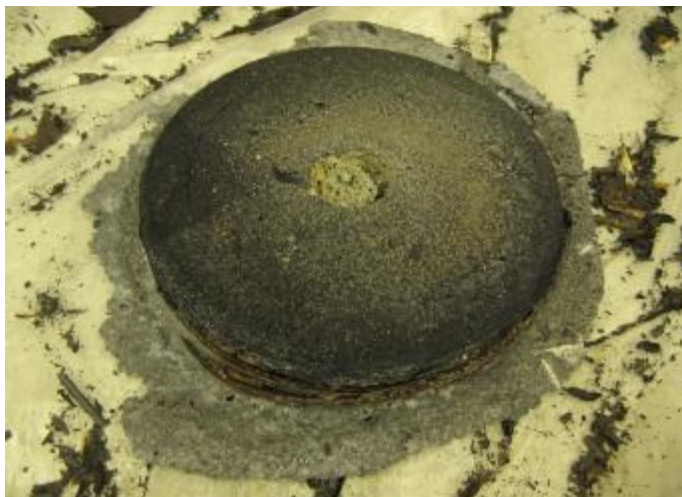
35. POLYPROPYLENE FILM CAN - AFTER

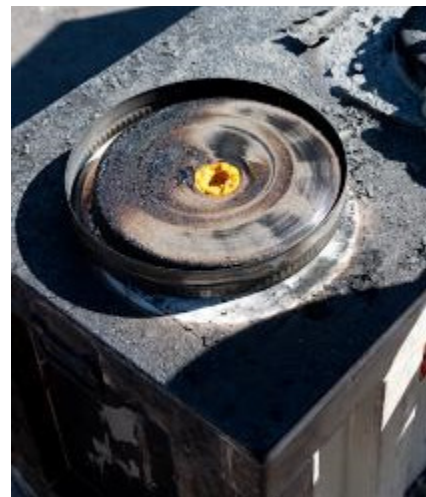
36. METAL FILM CAN – AFTER, OPEN

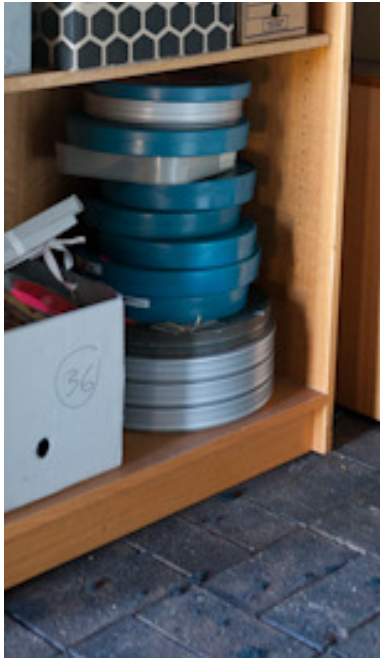
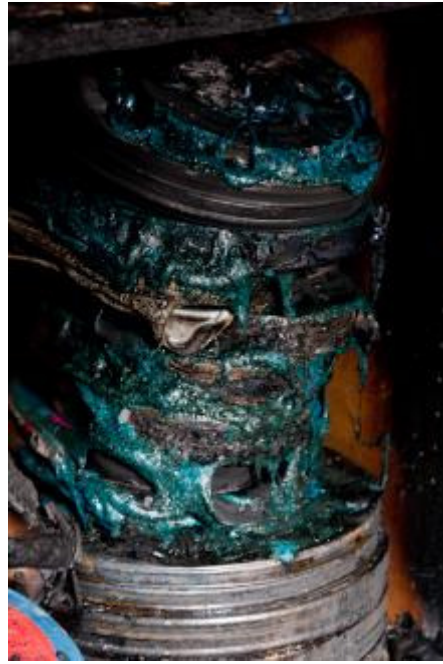
37 & 38. STACK OF FILM CANS — BEFORE AND AFTER

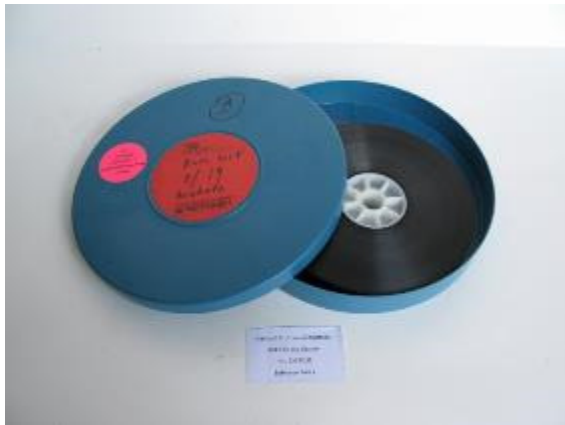
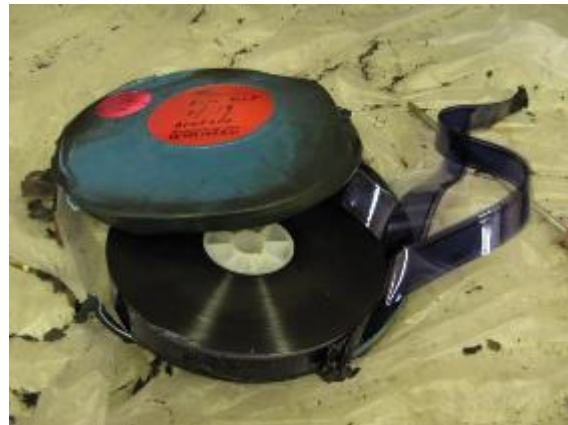
39 & 40. ACETATE FILM IN POLYPROPYLENE CAN - BEFORE AND AFTER

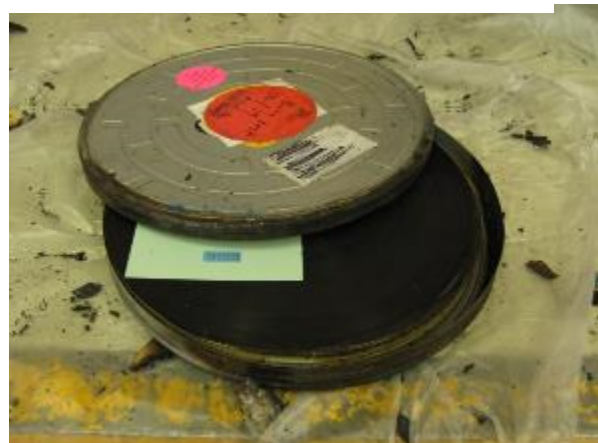
41 & 42. ACETATE FILM IN STEEL CAN - BEFORE AND AFTER

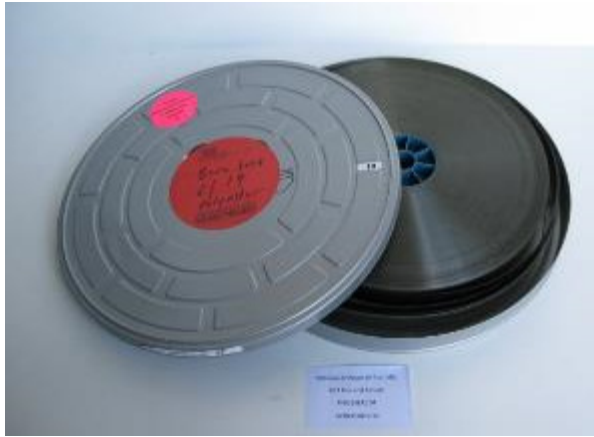
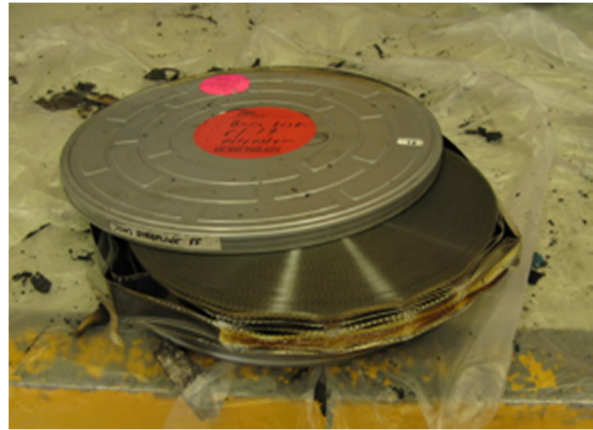
43 & 44. POLYESTER FILM IN STEEL CAN - BEFORE AND AFTER

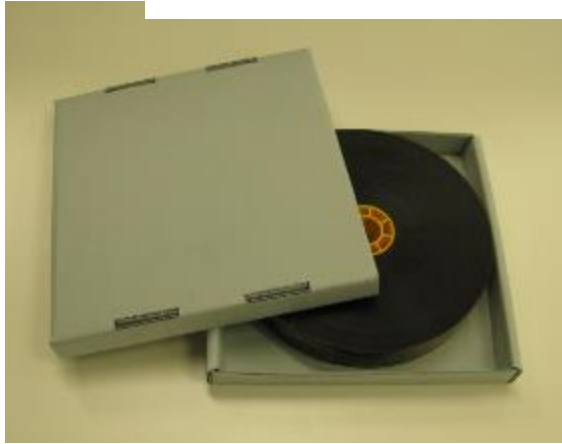
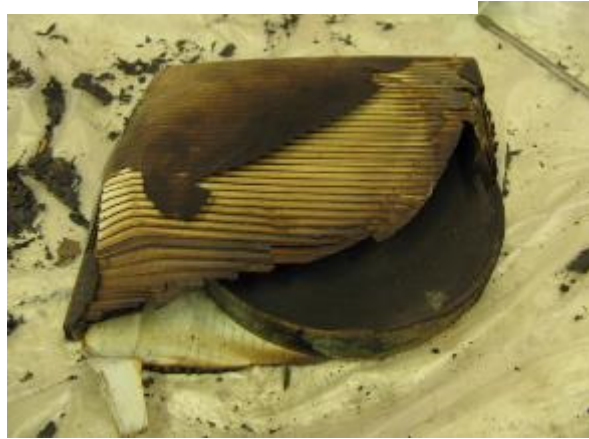
45 & 46. ACETATE FILM IN CORRUGATED PAPERBOARD BOX - BEFORE AND AFTER

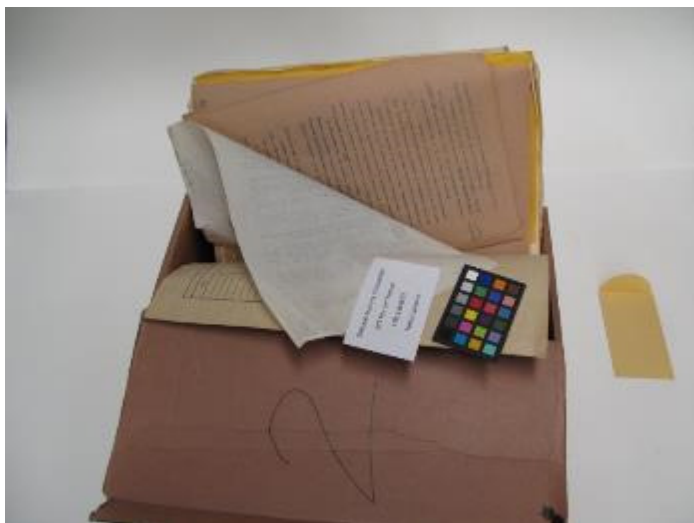
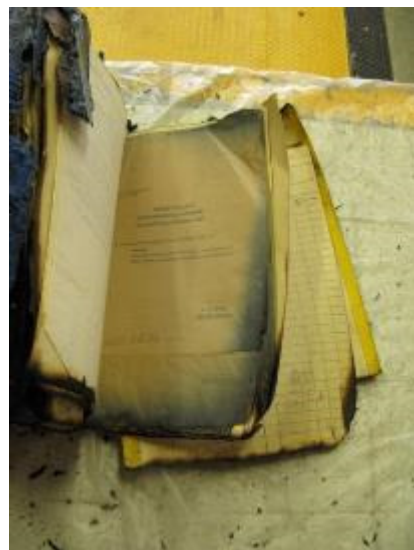
Thermal papers within file material did not totally blacken as expected. Blackening was restricted to the edges where the heat was most intense (Figs 47 & 48).

47 & 48. THERMOFAX PAPERS BEFORE AND AFTER THE FIRE

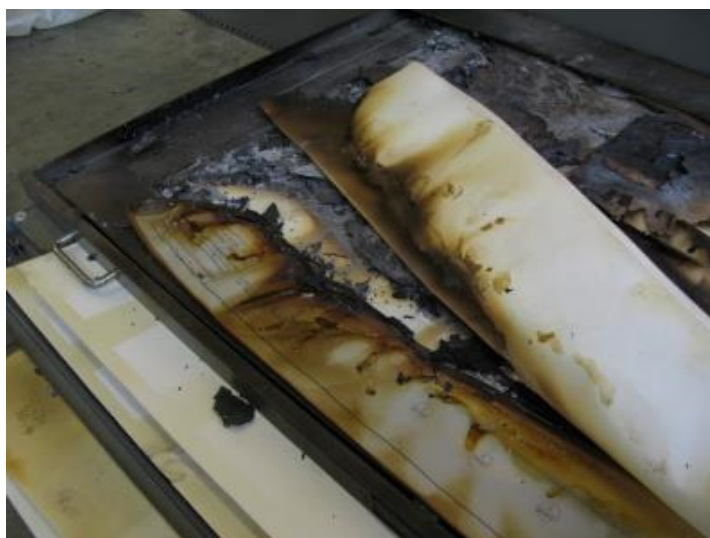
50. AFTER

The plan cabinet was sitting on the floor and as such received less heat than materials sitting high up. The greatest damage was to material in the top two drawers. These drawers held plans on plastic drafting film within paperboard folders and were significantly damaged from both burning and melting (Figs 49 & 50).

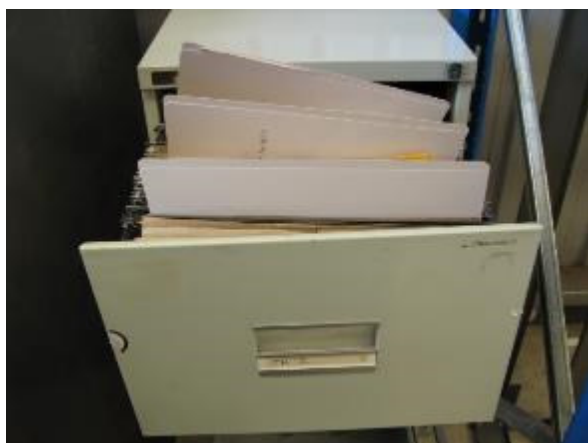
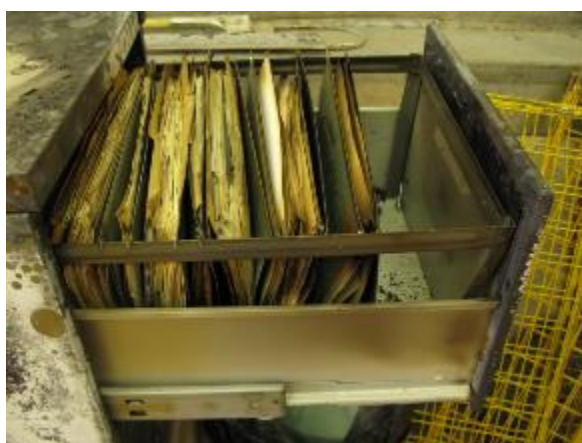
**What protection is afforded by filing cabinets and wooden drawer units?** The contents of the top drawer of the metal filing cabinet were singed and somewhat brittle but had not burnt. There was minimal obvious damage in the lower drawers (Figs 51 & 52).

51 & 52. TOP DRAWER OF THE METAL FILING CABINET — BEFORE AND AFTER

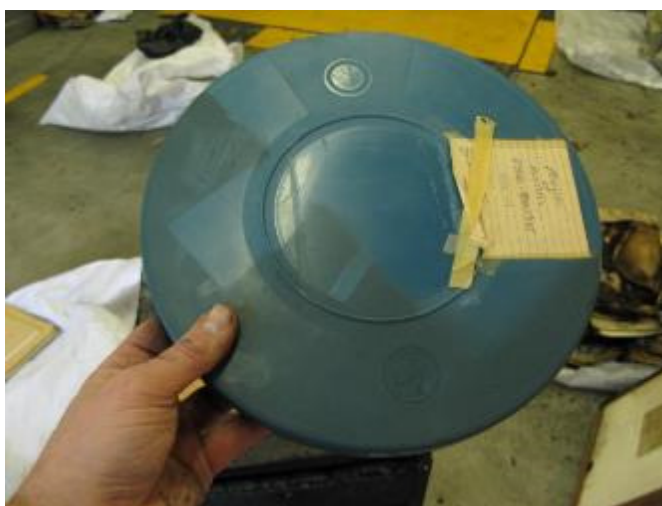
Within the small wooden drawer unit were stored various audio visual materials, these seem to have off gassed a brown oily material which deposited itself on the materials in the unit (Figs 53 & 54). We have done XRF analysis of this material and it has revealed that the material includes levels of chlorine, silicone, magnesium as well as possible slight traces of metals such as antimony, molybdenum and lead. All of these elements occur in various fire retardant materials, for example magnesium hydroxide, Dechlorane plus (Bis(hexachlorocyclopentadieno)cyclooctane) and molybdenum trioxide. Such chemicals are added to plastics and are designed to become volatile at high temperatures. They suppress fire by interfering with the chemical reactions that produce flame and heat. Of course some elements of the material could also be the result of the breakdown of plastics such as PVC. The health issues of all of these materials should be of concern to anyone working with these materials, particularly in the aftermath of a fire.

54. POLYPROPYLENE FILM CAN — BROWN DEPOSIT, POSSIBLY FIRE RETARDANT

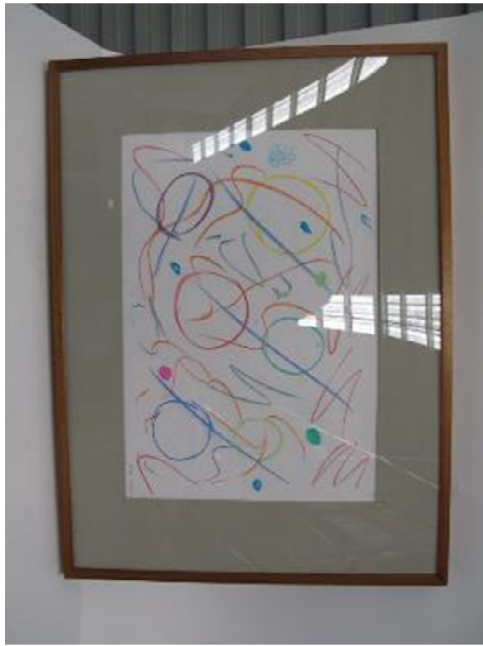
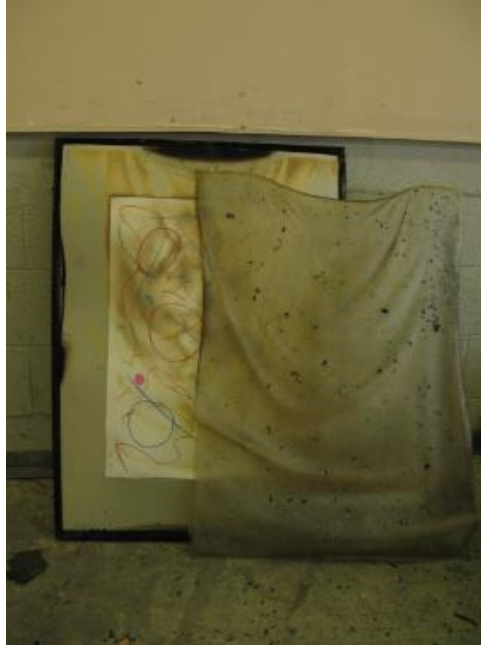
The exercise did not answer this with any certainty. The Perspex glazing melted and slumped (Figs 55 & 56) whilst the glass shattered (Figs 57 & 58). We had both aluminium frames and wooden frames — the aluminium burnt where it got the hottest and the wooden frames also charred. The artworks within charred where the heat reached them (Figs 57-62).

55 & 56. WOODEN FRAME AND PERSPEX GLAZING (FINI FRAME) — BEFORE AND AFTER

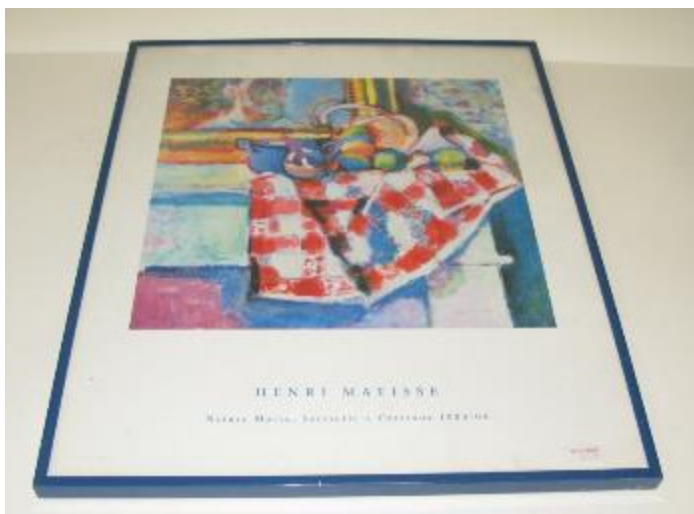
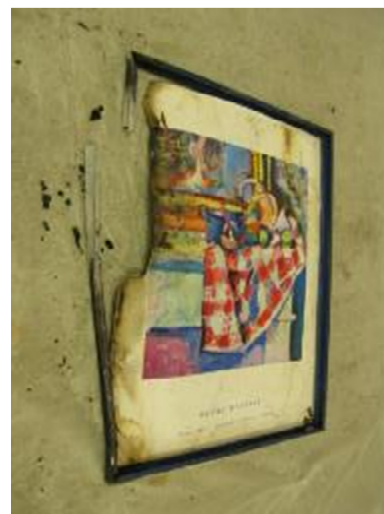
59 & 60. METAL FRAME AND GLASS GLAZING — BEFORE AND AFTER

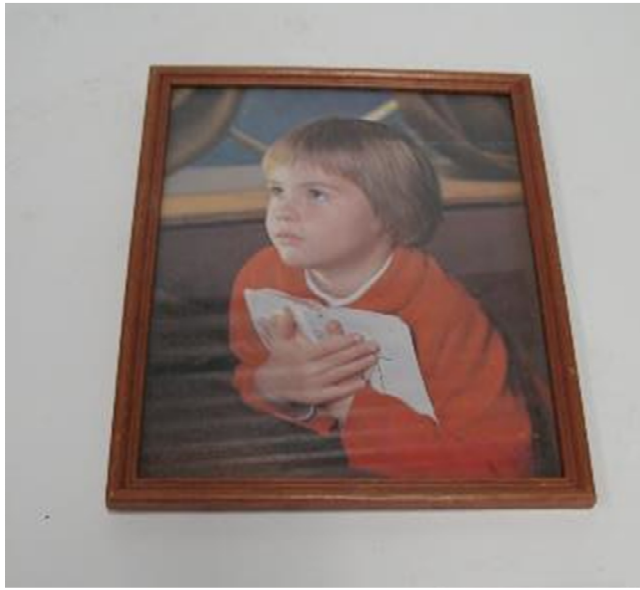
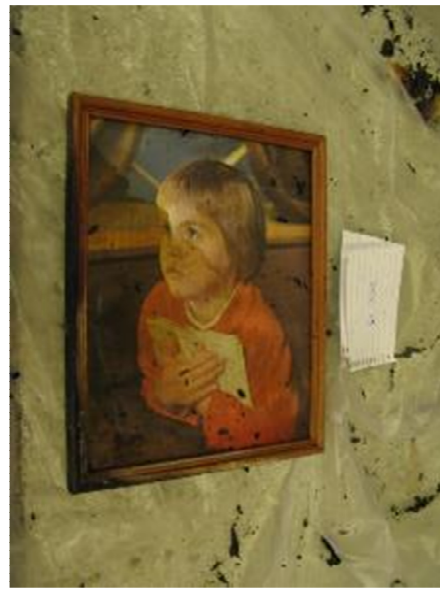
61 & 62. UNGLAZED PHOTO IN WOODEN FRAME STORED IN CORRUGATED PAPERBOARD BOX - BEFORE AND AFTER

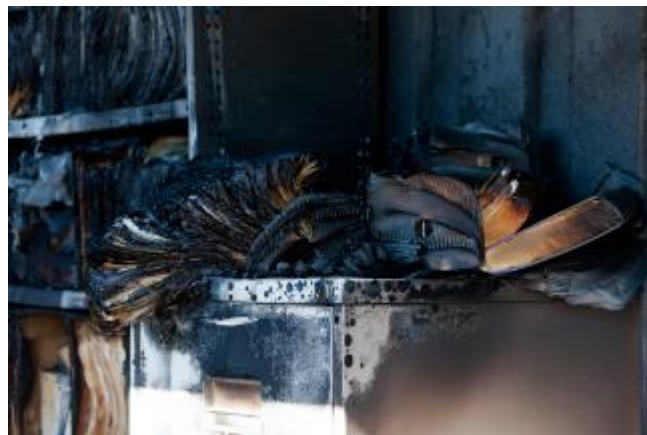
It was clear that damage was less for items packed on shelves rather than sitting out in the open. It was less clear whether loosely packed items within a box were more vulnerable than tightly packed ones (Figs 63-66).

64. EXPOSED CORRUGATED PAPERBOARD BOXES — AFTER PHOTOGRAPHER JENNIFER EVERART

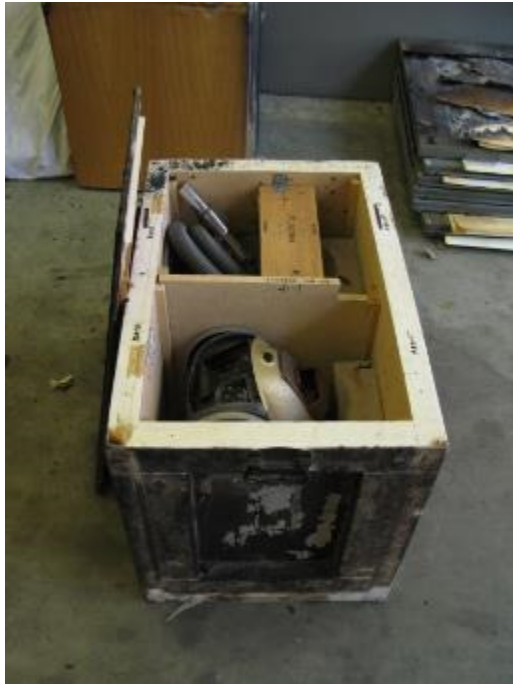
We had only one transport crate in the exercise. This came from the AWM and had very thick MDF walls. The fake object in was a small plastic vacuum cleaner. The crate was placed on the floor, very close to the fire. The lid of the crate charred significantly and the sides blackened but the contents had not sustained any obvious damage (Figs 67-69).

69. EXHIBITION TRANSPORT CRATE - AFTER

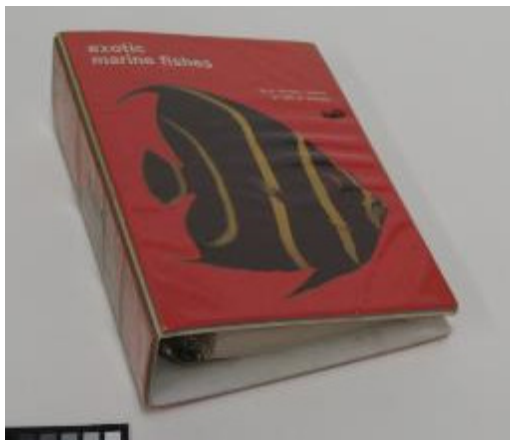
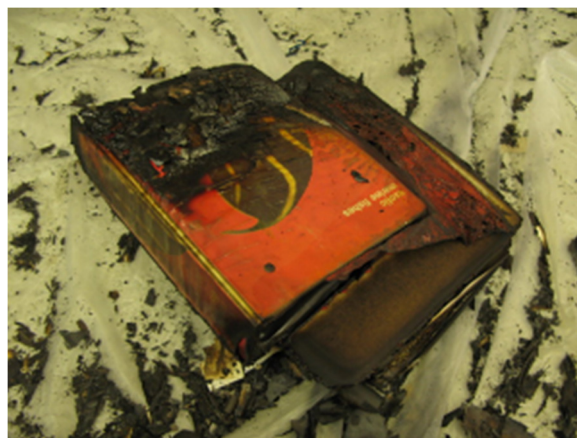
A small number of books and ring binders were included in the exercise. They were mostly placed in different boxes with a few items exposed. The PVC covers of exposed ring binders melted and burnt (Figs 70 & 71). Books stored in boxes were stained, singed and embrittled (Figs 72 & 73).

70 & 71. EXPOSED RING BINDER - BEFORE AND AFTER

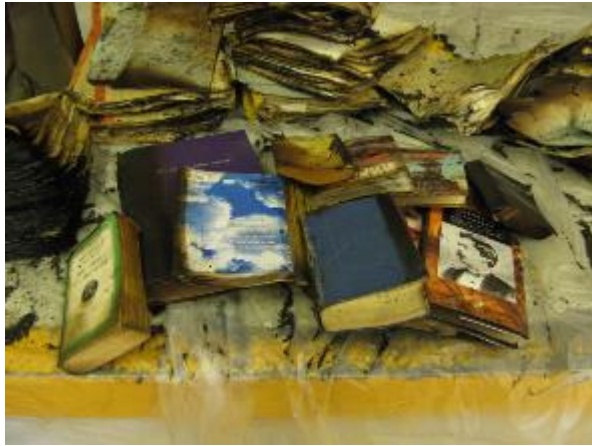
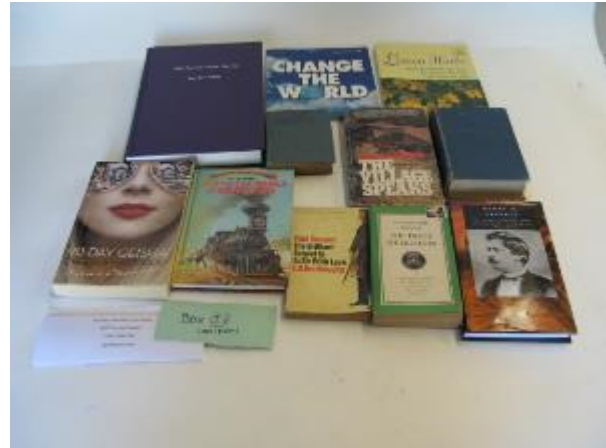
72 & 73. VARIOUS BOOKS STORED IN BOXES - BEFORE AND AFTER

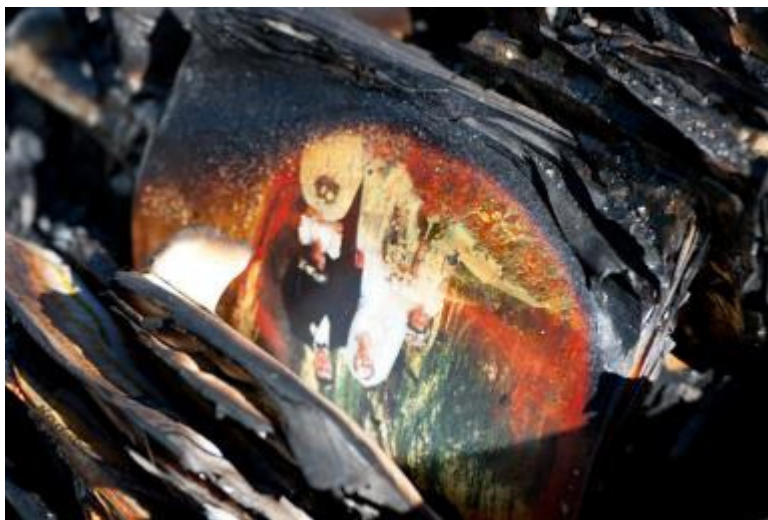
A variety of photographic materials were included in the exercise. These were boxed in a number of configurations. Few of the materials received sufficient heat to develop visible problems. An exception was a group of modern colour photos that received enough heat to char at the edges. The un-charred portion of the image had developed a strong orange cast, most likely through loss of one or more of the colour dyes making up the image (Fig 74).

74. FIRE AFFECTED COLOUR PHOTOS

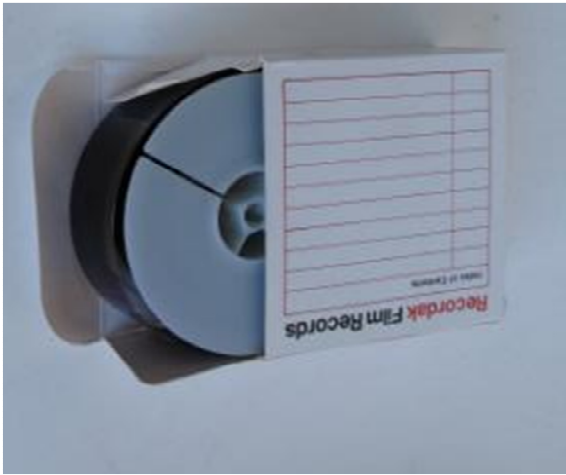
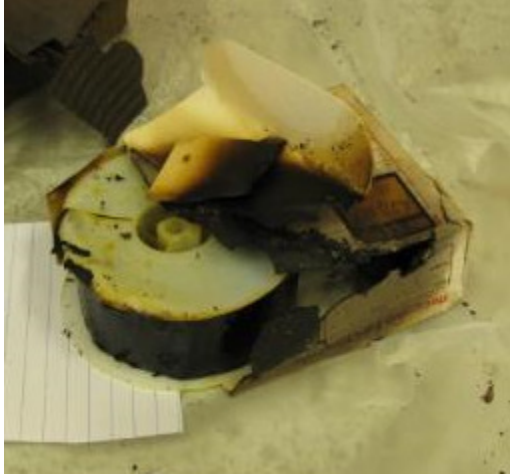
A variety of AV materials were included in the exercise. These were boxed in a number of configurations or stored in drawers. Few of the materials received sufficient heat to develop visible problems. Where problems were obvious they comprised melting and/or burning of the housing where heat was the most intense (Figs 75 & 76). Unfortunately it was not possible to assess the play-ability of these formats before and after the exercise. Careful observation of a group of audio cassettes (Figs 77 & 78) suggests the cases have melted as a result of heat entering the box through a finger hole.

75 & 76. ROLL OF MICROFILM — BEFORE AND AFTER

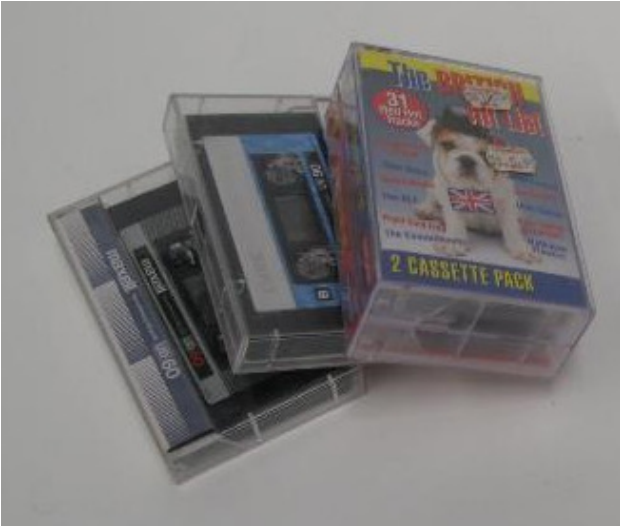
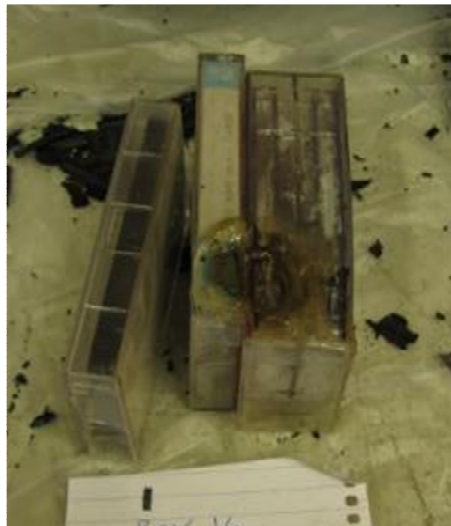
77 & 78. AUDIO CASSETTES — BEFORE AND AFTER
