**Number 51**

**March 2015**

**National Archives of Australia/ACT Fire & Rescue. Part 1  
Fire simulations 2012 and 2013 – Ian Batterham.**

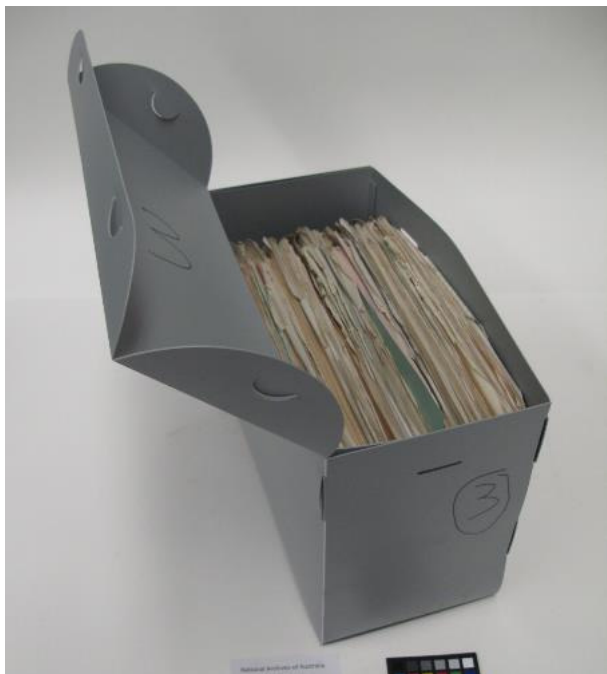
There was a distinct difference between materials stored in corrugated paperboard, when compared to material stored in polypropylene (whether fluted or not). The corrugated paperboard burnt but in doing so appeared to protect the material stored within. The polypropylene boxes on the other hand melted and left the contents exposed to the fire. The lid of the box when melted ran into the box, covering the contents (Figs 23-29).

25. POLYPROPYLENE BOX (ALBOX) PACKED ON SHELVING -BEFORE

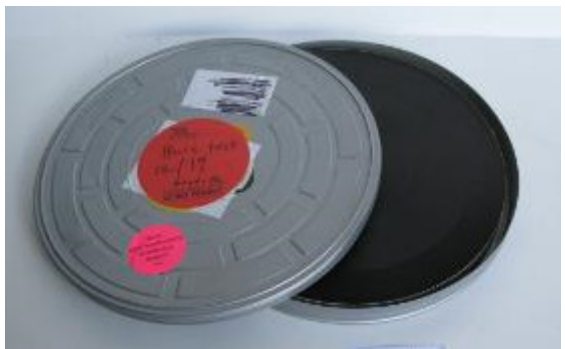
It is very difficult to make a conclusion about this question. Plastic containers tended to melt, metal containers appear to have acted like ovens and the paperboard container charred. In each case there was significant damage to the film inside and it was not possible to say which film received the worse damage (Figs 33-45).

41 & 42. ACETATE FILM IN STEEL CAN - BEFORE AND AFTER

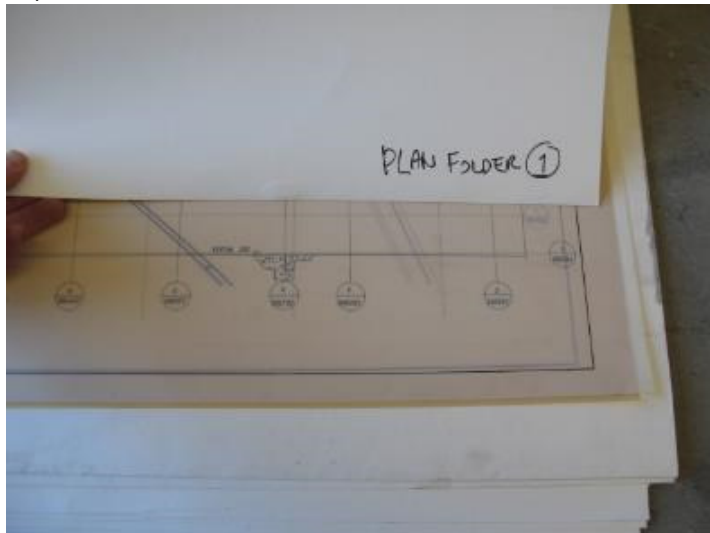
49. BEFORE

The plan cabinet was sitting on the floor and as such received less heat than materials sitting high up. The greatest damage was to material in the top two drawers. These drawers held plans on plastic drafting film within paperboard folders and were significantly damaged from both burning and melting (Figs 49 & 50).

THE TOP DRAWER OF  
THE PLAN CABINET

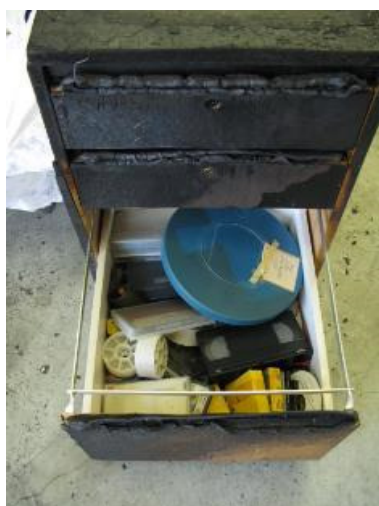
Within the small wooden drawer unit were stored various audio visual materials, these seem to have off gassed a brown oily material which deposited itself on the materials in the unit (Figs 53 & 54). We have done XRF analysis of this material and it has revealed that the material includes levels of chlorine, silicone, magnesium as well as possible slight traces of metals such as antimony, molybdenum and lead. All of these elements occur in various fire retardant materials, for example magnesium hydroxide, Dechlorane plus (Bis(hexachlorocyclopentadieno)cyclooctane) and molybdenum trioxide. Such chemicals are added to plastics and are designed to become volatile at high temperatures. They suppress fire by interfering with the chemical reactions that produce flame and heat. Of course some elements of the material could also be the result of the breakdown of plastics such as PVC. The health issues of all of these materials should be of concern to anyone working with these materials, particularly in the aftermath of a fire.

53. WOODEN DRAWER UNIT WITH FILM AND VIDEO

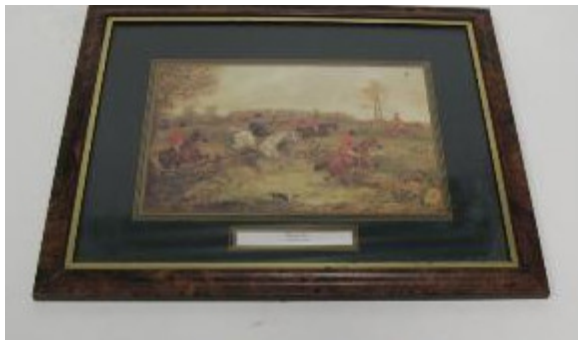
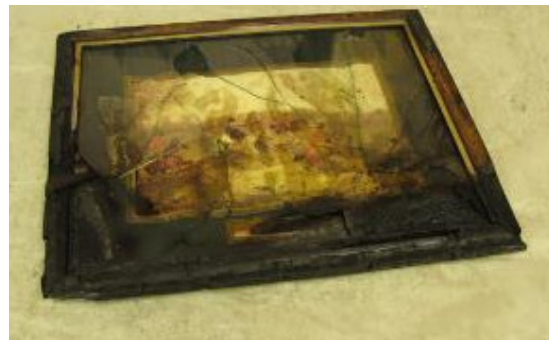
The exercise did not answer this with any certainty. The Perspex glazing melted and slumped (Figs 55 & 56) whilst the glass shattered (Figs 57 & 58). We had both aluminium frames and wooden frames — the aluminium burnt where it got the hottest and the wooden frames also charred. The artworks within charred where the heat reached them (Figs 57-62).

57 & 58. WOODEN FRAME AND GLASS GLAZING — BEFORE AND AFTER

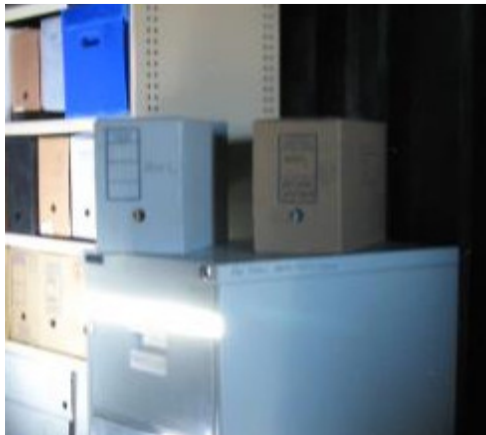
It was clear that damage was less for items packed on shelves rather than sitting out in the open. It was less clear whether loosely packed items within a box were more vulnerable than tightly packed ones (Figs 63-66).

63. EXPOSED CORRUGATED PAPERBOARD BOXES - BEFORE

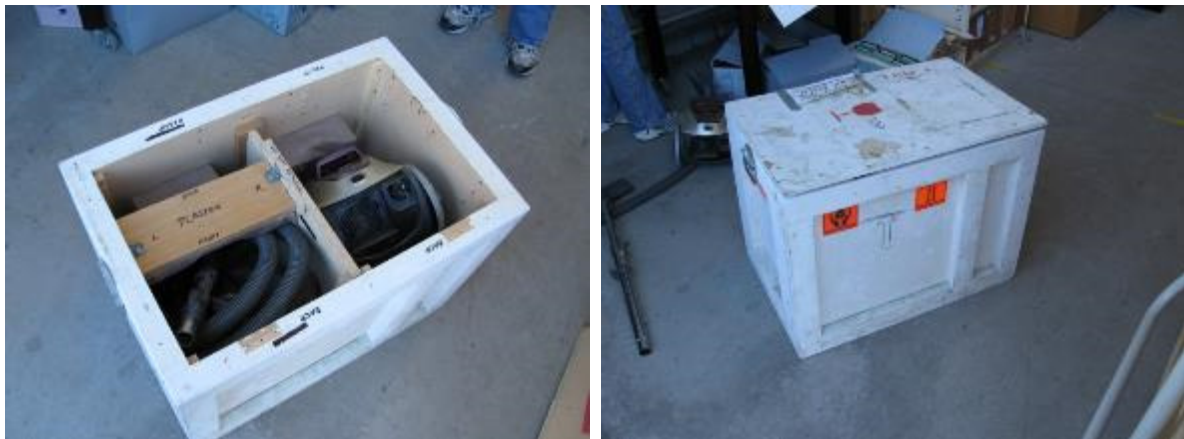
We had only one transport crate in the exercise. This came from the AWM and had very thick MDF walls. The fake object in was a small plastic vacuum cleaner. The crate was placed on the floor, very close to the fire. The lid of the crate charred significantly and the sides blackened but the contents had not sustained any obvious damage (Figs 67-69).

67 & 68. EXHIBITION TRANSPORT CRATE - BEFORE
