Second Exercise

September 2015

**National Archives of Australia/ACT Fire & Rescue. Part 2
Fire simulations 2012 and 2013 – Ian Batterham.**

Second exercise: 24 May 2013

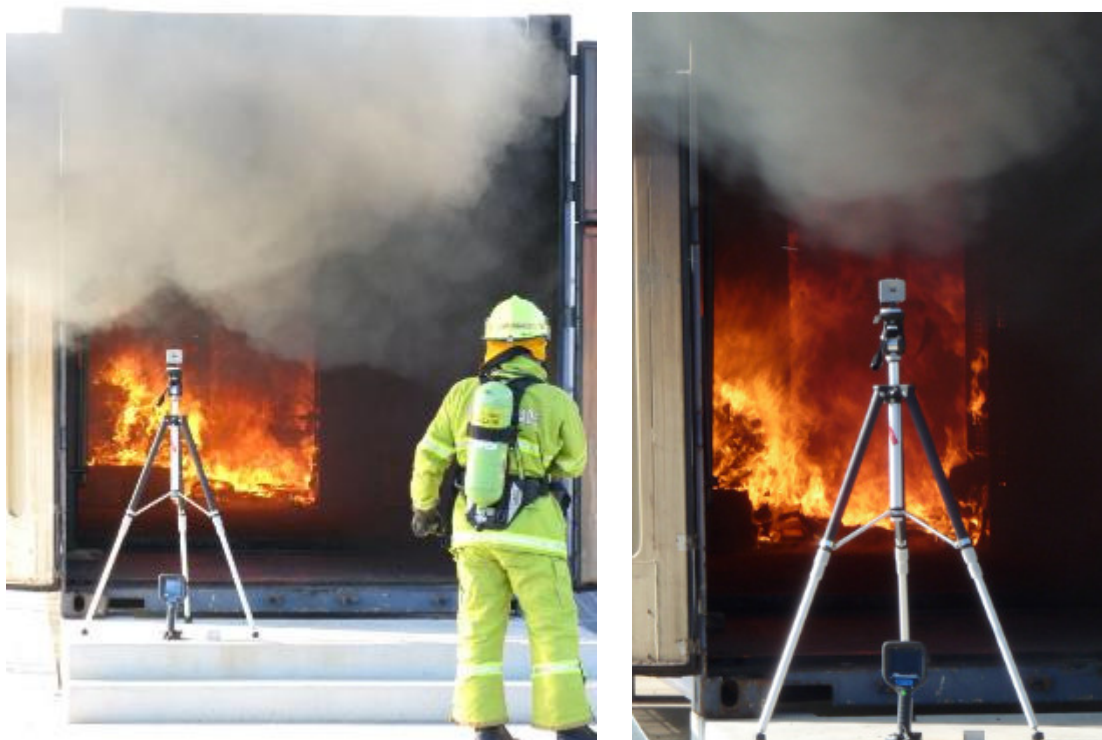
Later stages of the fire – pile of boxes and contents of metal shelving well alight. Paintings fallen on floor and burning

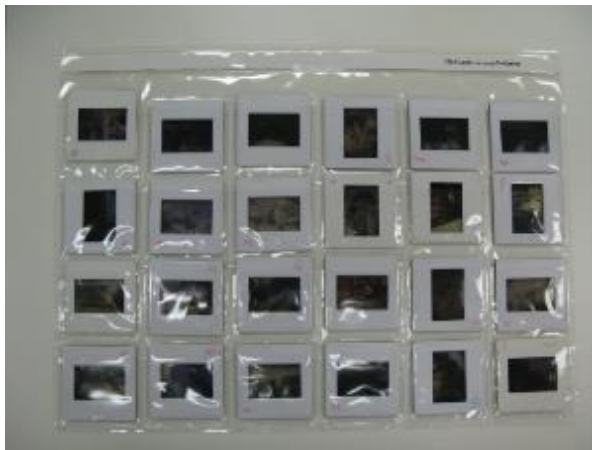
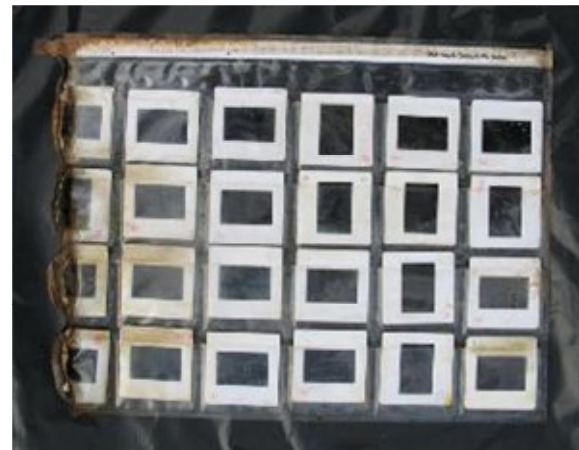
3. Slide sleeves

The slide sleeves, slide mounts and slide film all melted where the heat reached them

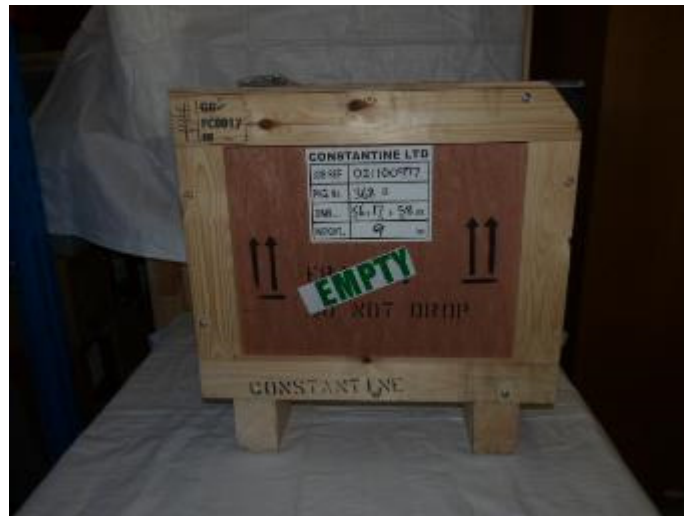
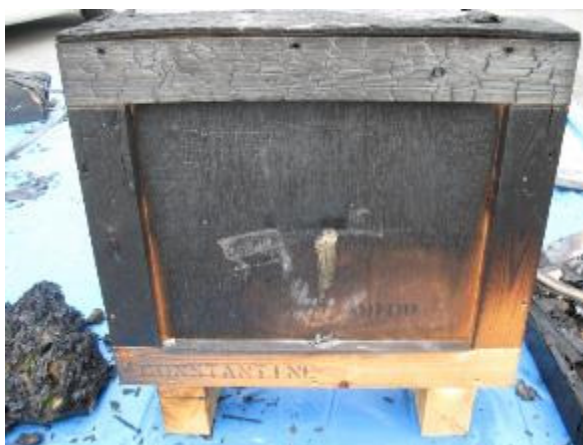
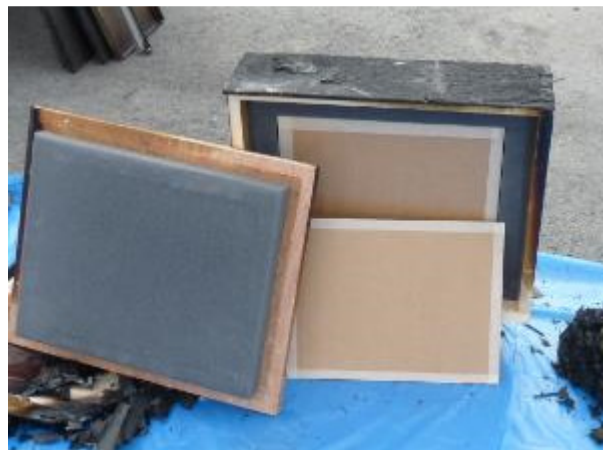
8. Storage and transport enclosures

The exhibition transport case was significantly charred on the outside. The interior was entirely unscathed.
